2nd IWA Leading-Edge Conference & Exhibition on  
**Strategic Asset Management**

**Evaluation of the pipeline replacement project for  
drinking water supply system using performance  
indicators**

**K. Ishii and T. Katsumata**

LESAM 2007 – Lisbon 17-19 October 2007

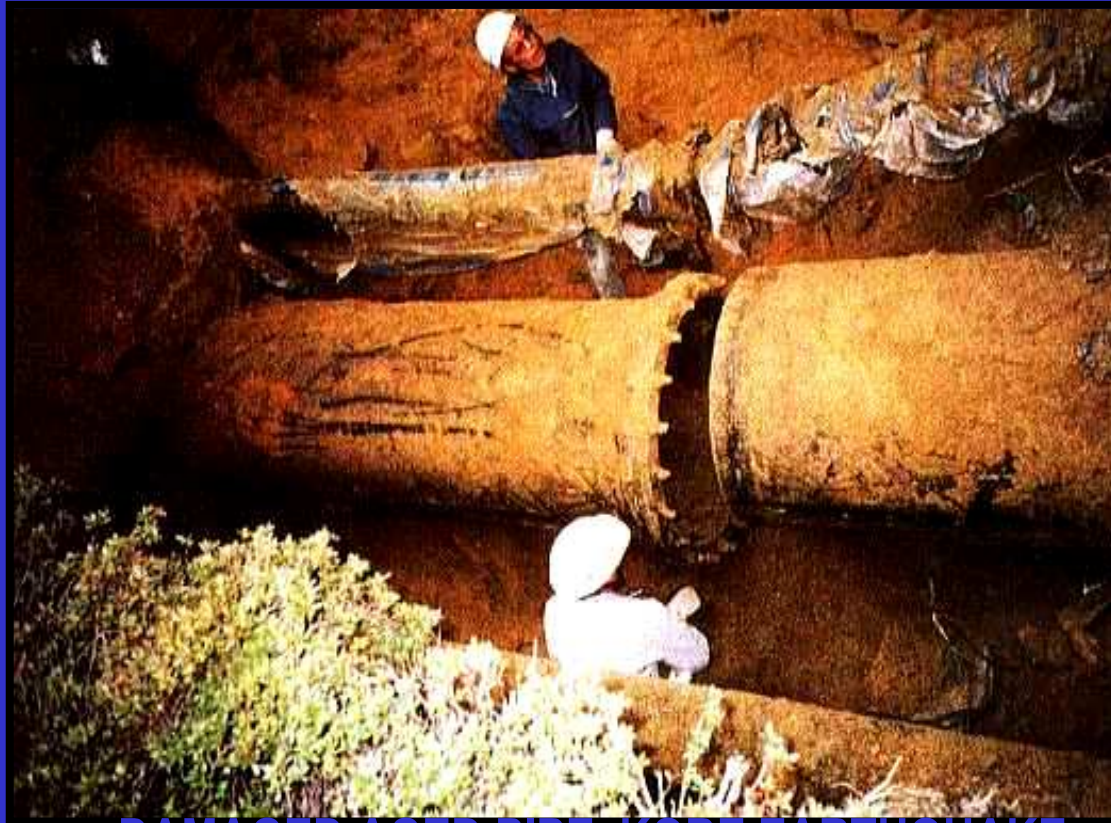
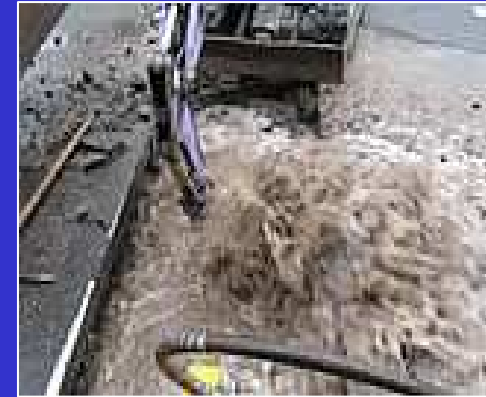
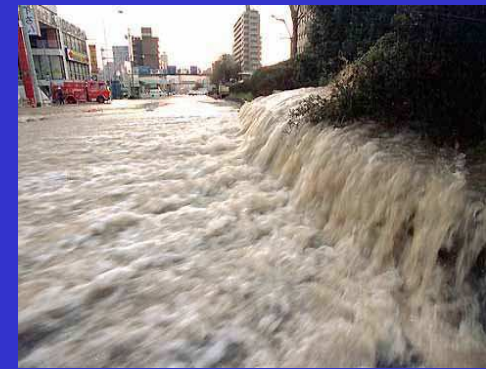
# 2 AGED PIPE RUPTURES

## KOBE EARTHQUAKE

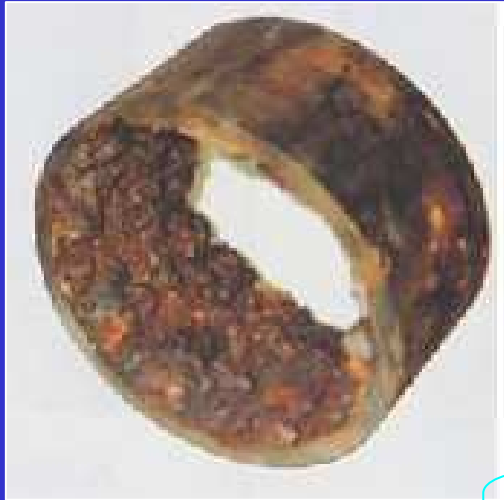
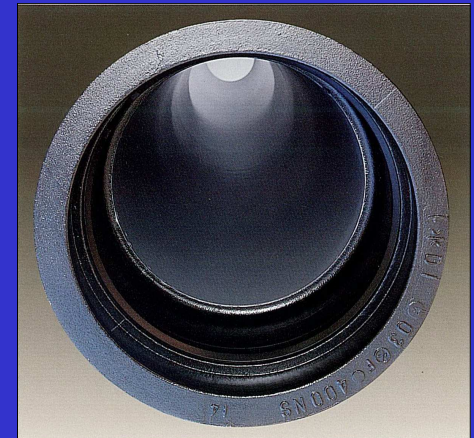
# 3 AGED PIPE > 40 years old

- Cast Iron Pipe, Asbestos Cement Pipe, Hard PVC
- No Earthquake Resistant joint
- Pipe material (FC) weak to shock
- Leakage, Failure, Rupture
- Rust colored water

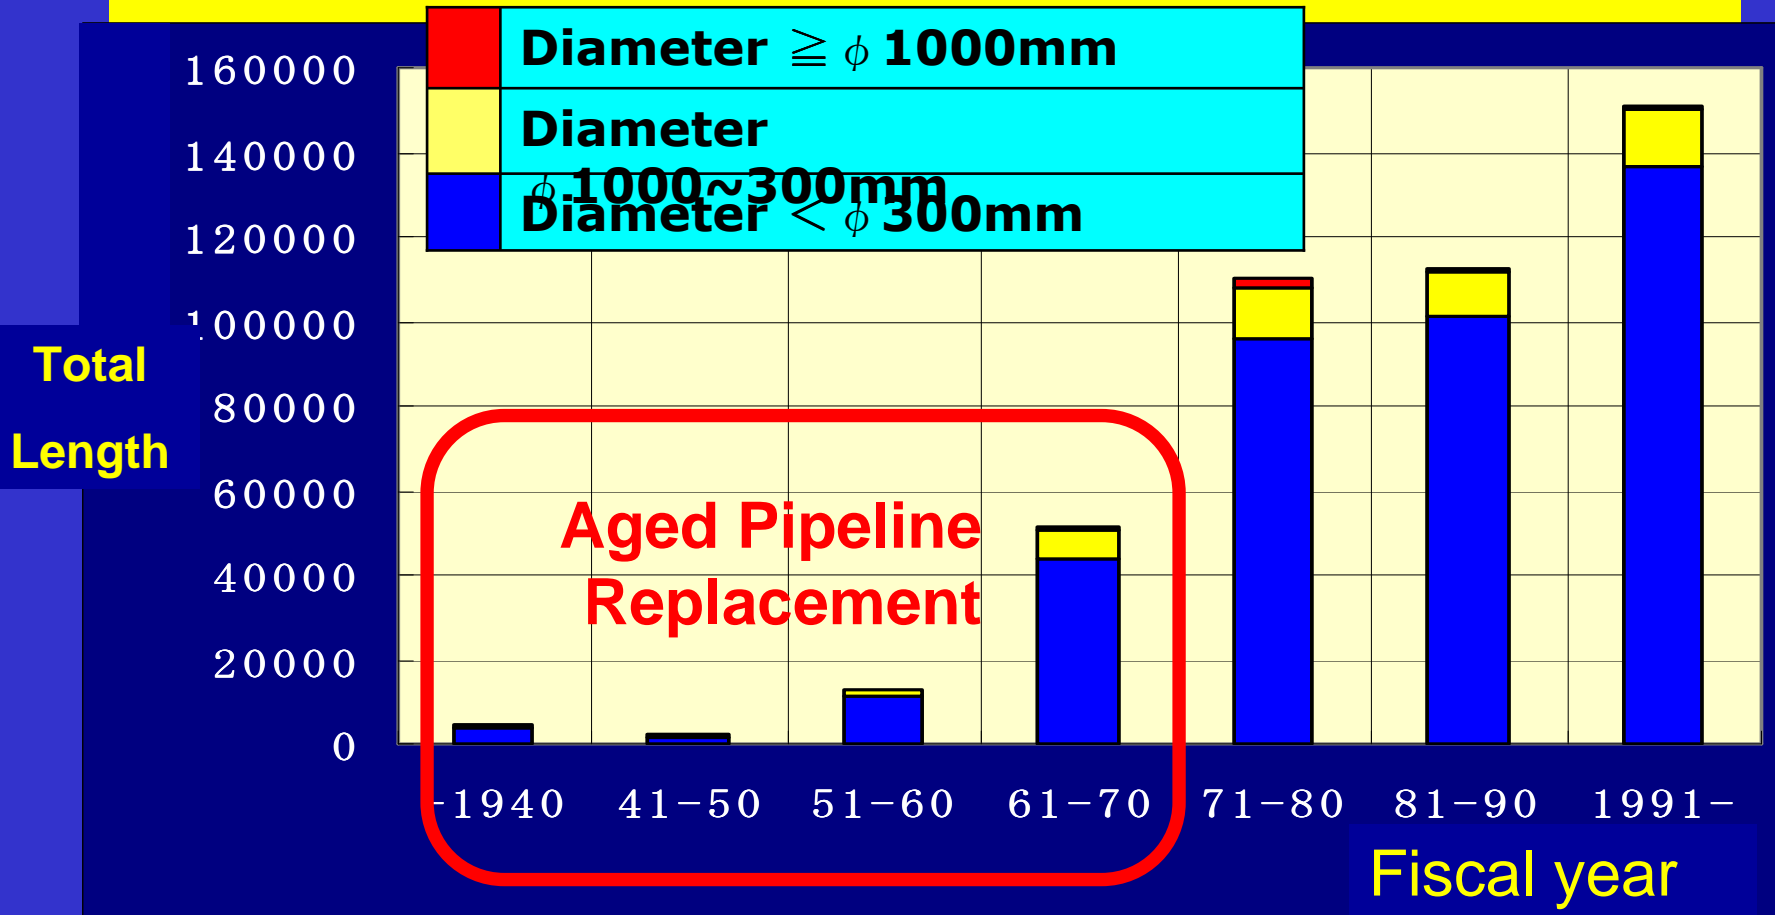
# 6 Total Length of Pipeline

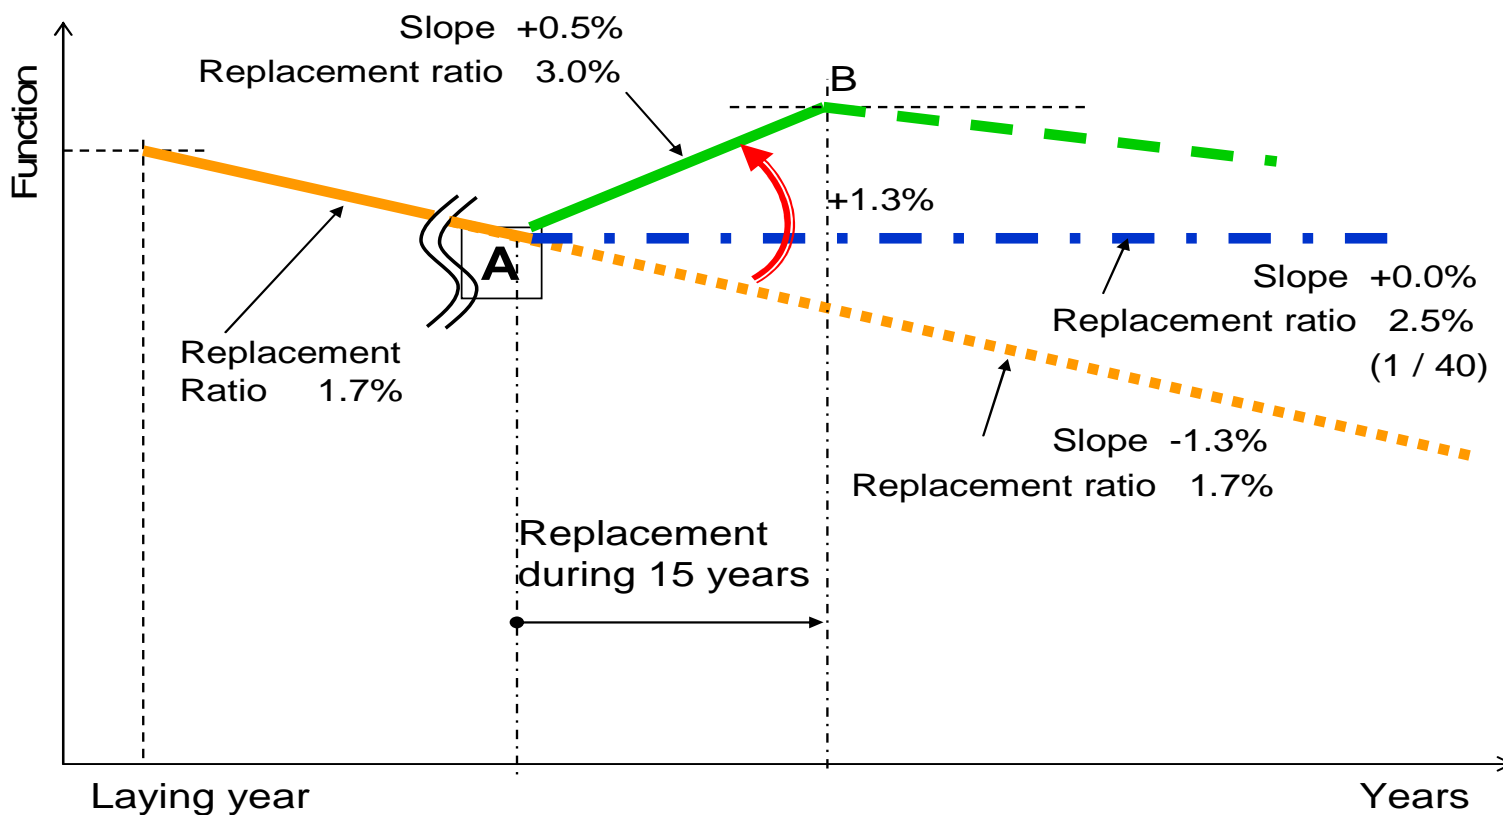
## 8 Conceptual relationship between the decrease in function of pipelines and its replacement

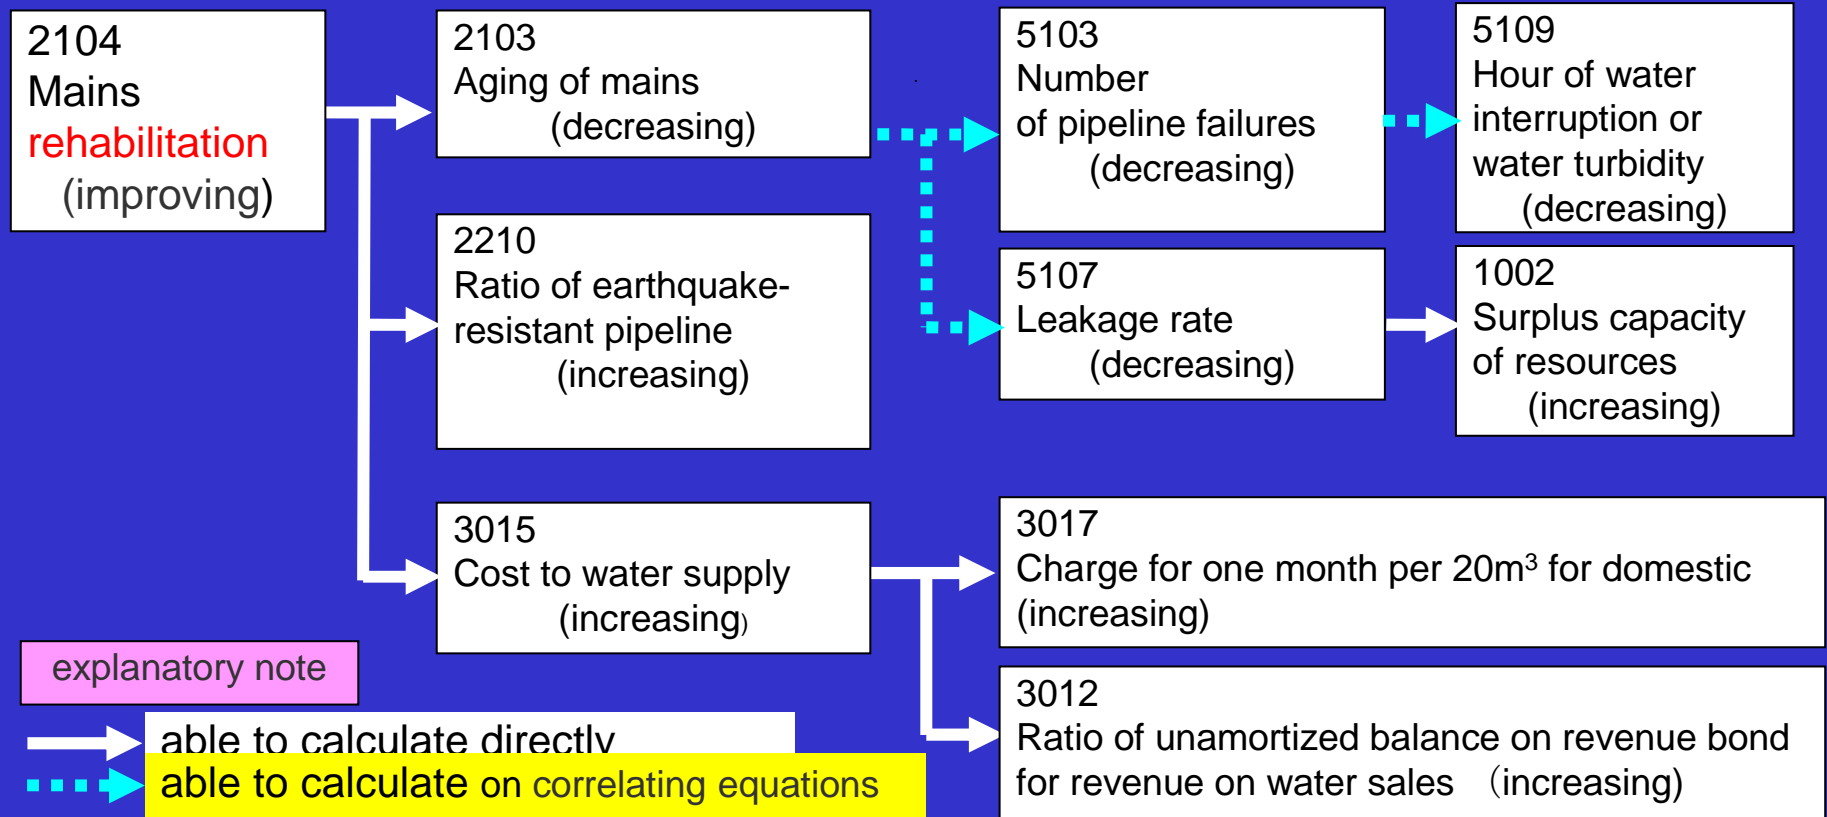
# 10 Reciprocal relationship of PIs and costs

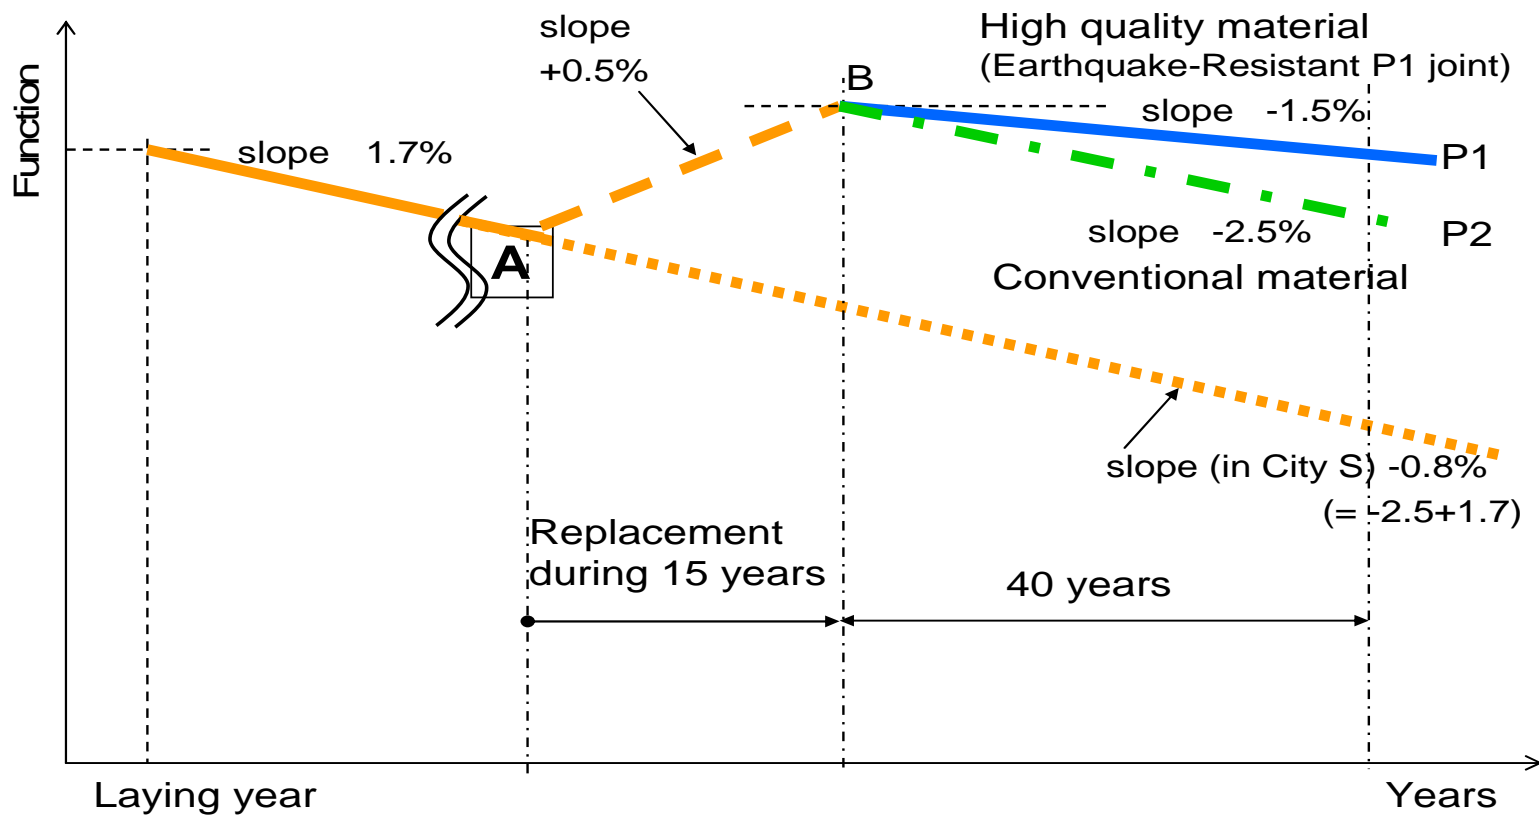
# 15 Difference between High quality material and Old material

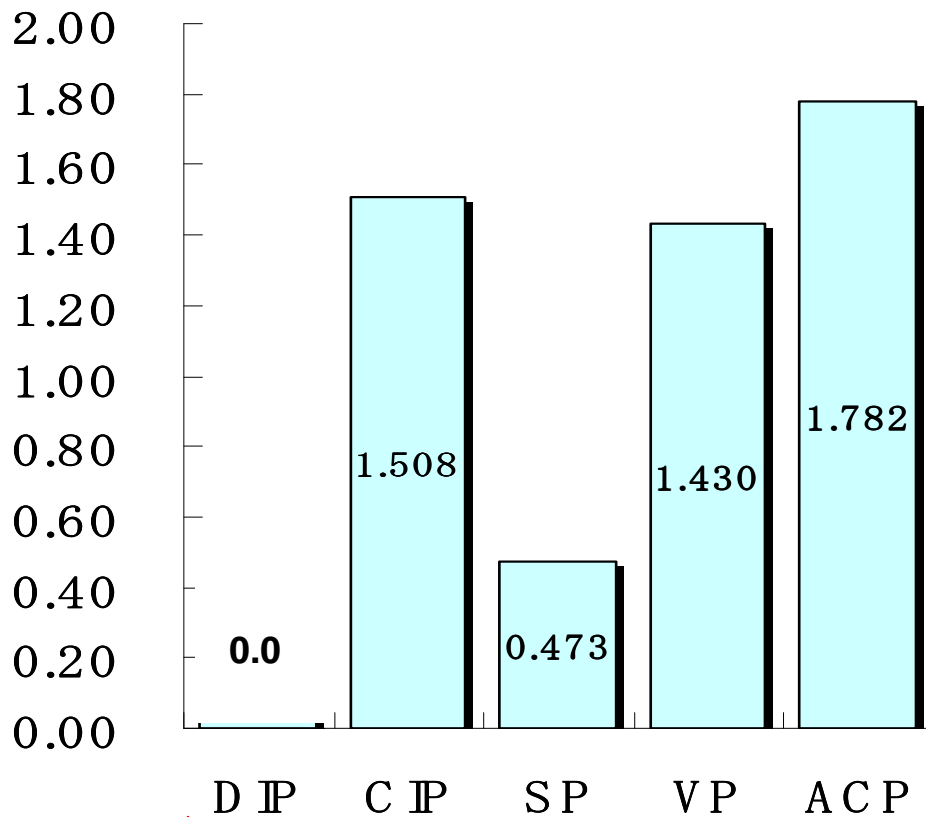
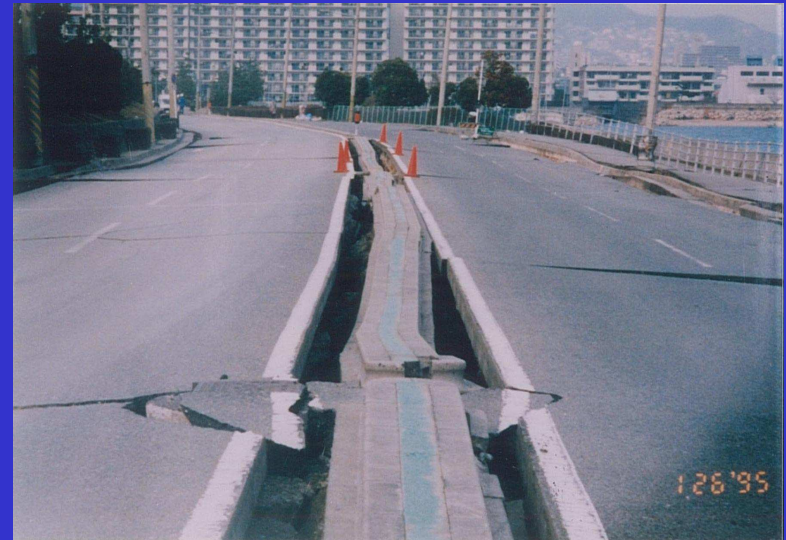
# Pipeline failures for earthquake (1995)

Number of pipeline failures (No./km)

DIP	Ductile iron pipe
	(FCD)
CIP	(with Ns joint)
SP	Cast-iron pipe
VP	(FC)
ACP	Steel pipe
	Hard PVC pipe
	Asbestos cement pipe
