2nd IWA Leading-Edge Conference & Exhibition on **Strategic Asset Management**

Degradation of lining systems for drinking water networks

**Sveinung Sægrov¹ Astrid Bjørgum¹, Eva Rodum¹ and Marit Haugen¹
Kjartan Reksten², Lars Wermskog² and Finn Bjørgum³**

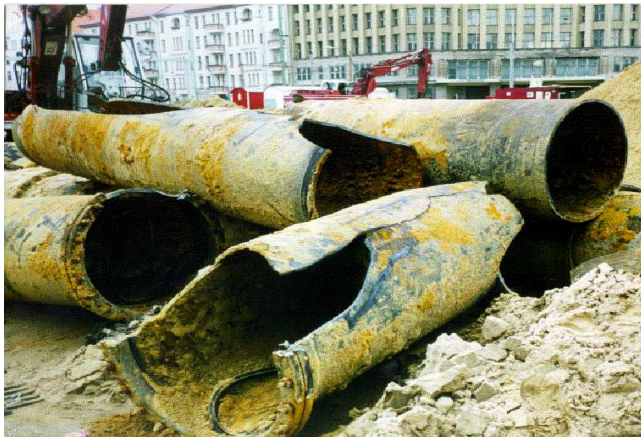
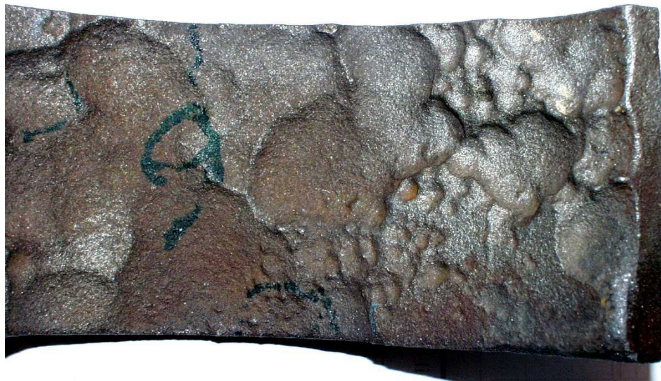
Corrosion is a major reason for bursts and leaks of metallic pipes as well as reduced water quality

Those pipes need to be protected

.....Corrosion may occur even through protection systems

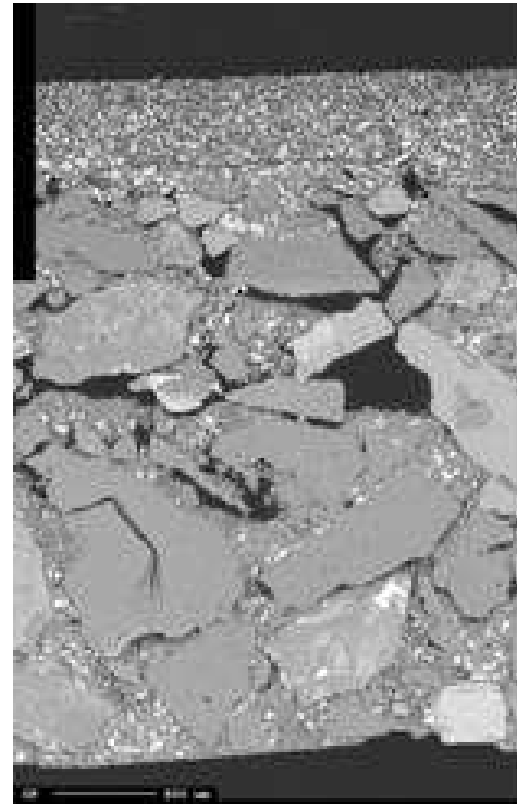
- **Cement type**
 - Standard Portland
 - Alumina
 - Modified cements (fly ash, blast furnace slag cement)
- **Lining method**
 - Rotating spray unit (homogenous protection layer)
 - Rotating pipe (dense protection layer towards water)

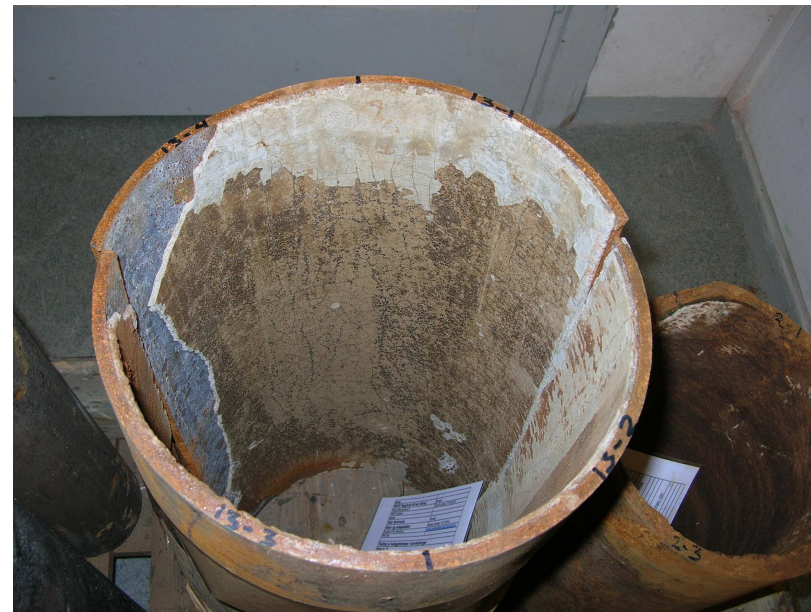
Visual test of in-situ lining: Uneven wall thickness

- The in-situ lined samples had uneven thicknesses
- All samples were degraded until depths from 2.1 to 5.0 mm (degraded zone represents a $\text{pH} < 9.5$)
- The majority of samples indicated corrosion attack and two of them were strongly affected

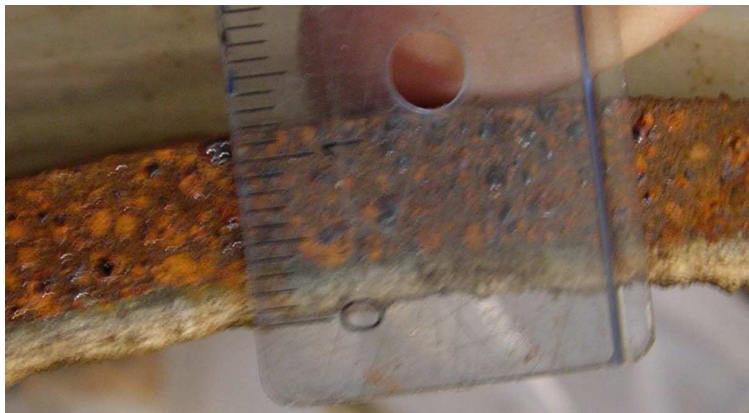
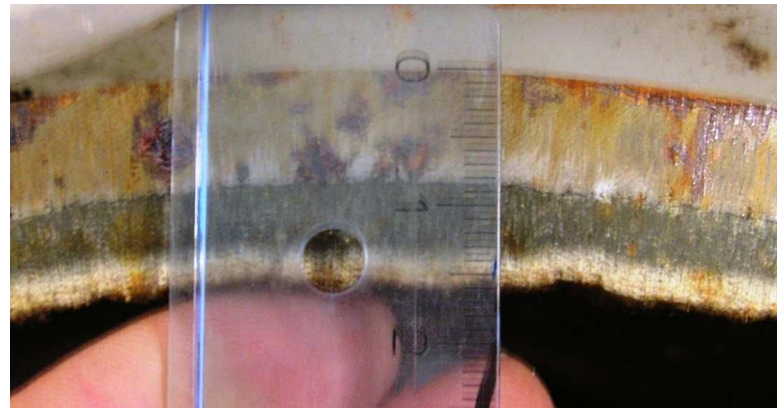
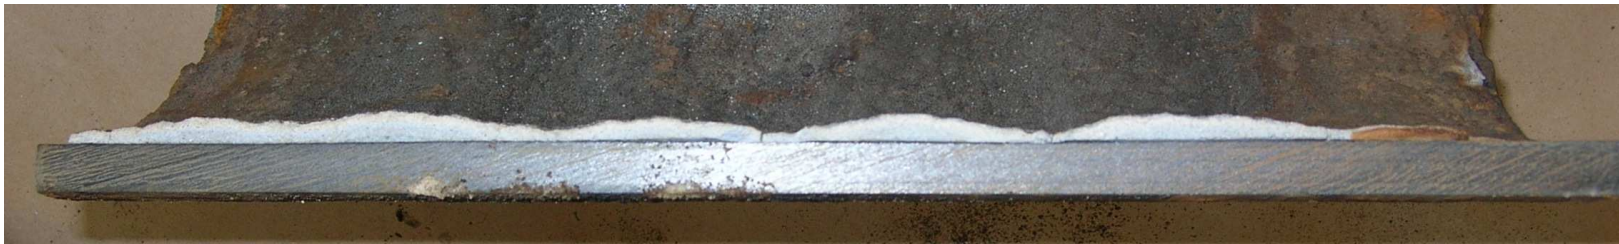
Results from lab investigations

- Lined at the producer (slag cement used)
 - 1974 "some signs of corrosion"
 - 1970 "some corrosion"
 - 1970 "no corrosion"
 - xxxx "significant corrosion"
 - 1977 "no corrosion"
 - 1975 "several corrosion spots"
- Lined on site (Portland cement used)
 - 1970 "significant corrosion"
 - 1998 "no signs of corrosion"
 - 1998 "no signs of corrosion"
 - 1997 "indices of corrosion"

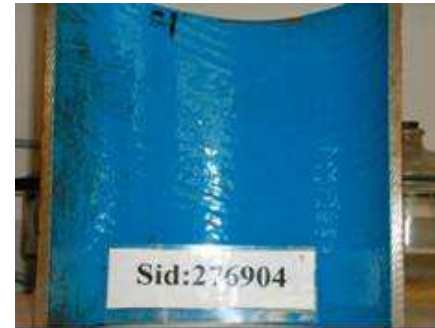
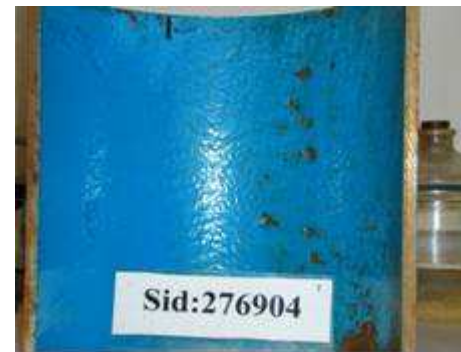
- Six test samples received at laboratory in 2006.
- Pipes originally built in 1966-70, renovated in 1998-2000
- Visual test to observe surface degradation
- Laboratory processes
 - Longitudinally cut, cleaned and inspected
 - Lining thickness
 - Adhesion to pipe surface

- General good corrosion protection, no blistering/corrosion under lining were observed
- Limited adhesion to pipe wall and partly delamination, but lining performance seem not affected by this
- Epoxy linings thinner than recommended today

- No degradation of CIPP linings were observed
- Stretch test indicated adequate adhesion to pipe wall
