Economical rehabilitation of sewer systems by ground penetration radar investigations

Institute of Environmental Engineering RWTH Aachen University

LESAM 2007 – Lisbon 17-19 October 2007

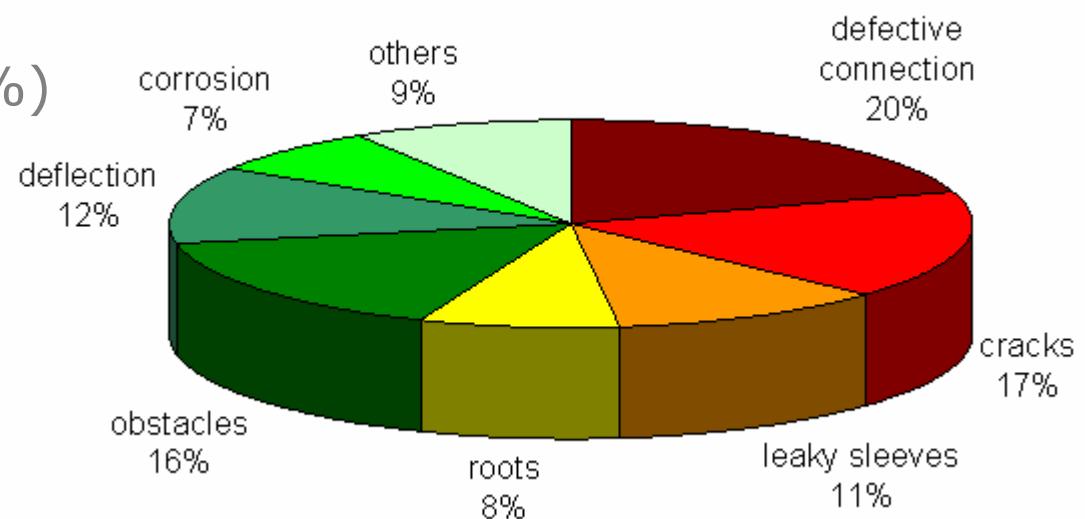
■ Distribution of sewer damages

- Defective connection (20%)
- Cracks (17%)
- Leaky sleeves (11%)
- Roots (8%)

■ Leaky sewers and pipes cause exfiltration of waste water or infiltration of groundwater

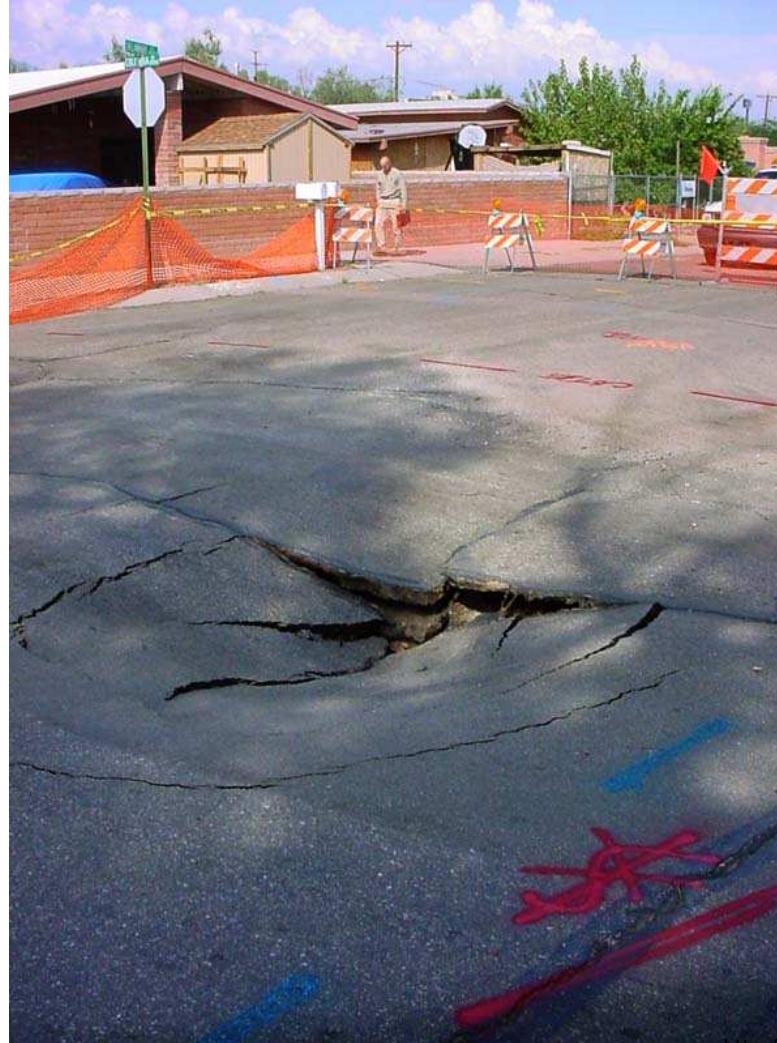
Sewer Collapse

Tucson, Arizona, September 2002

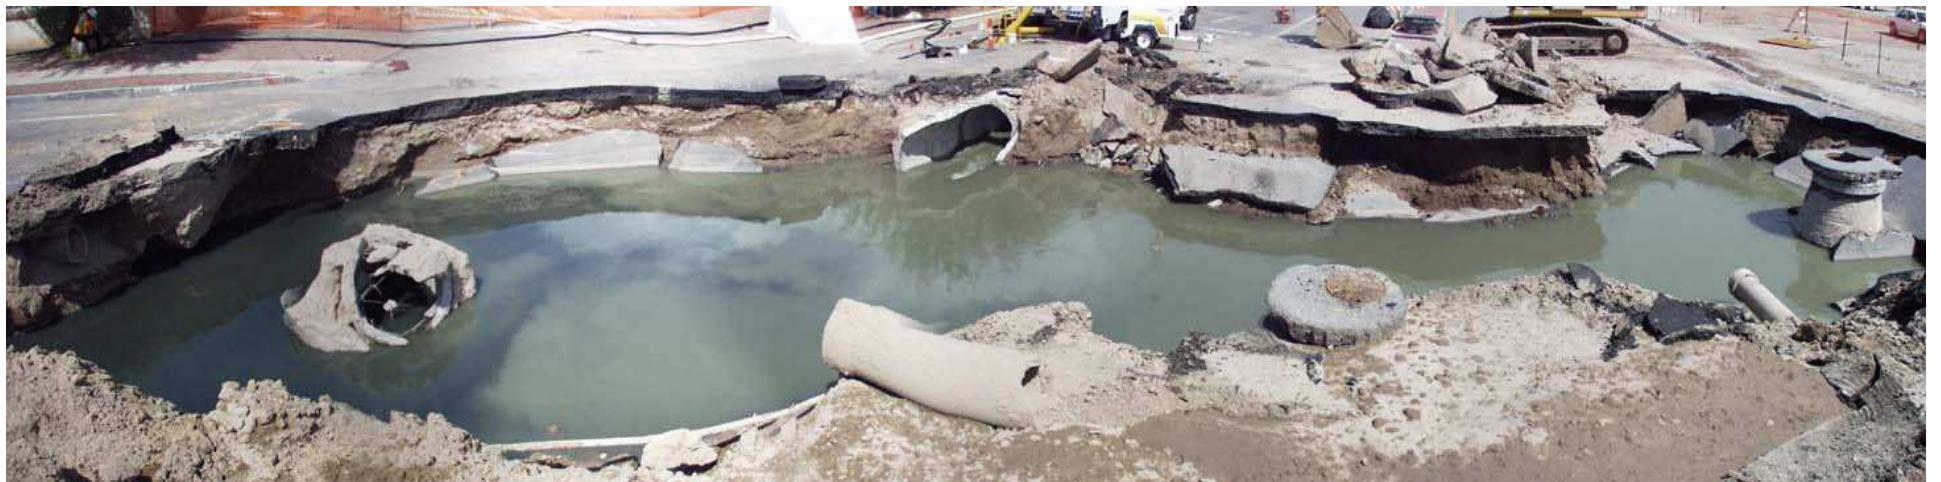
Sewer Collapse

Tucson, Arizona, September 2002

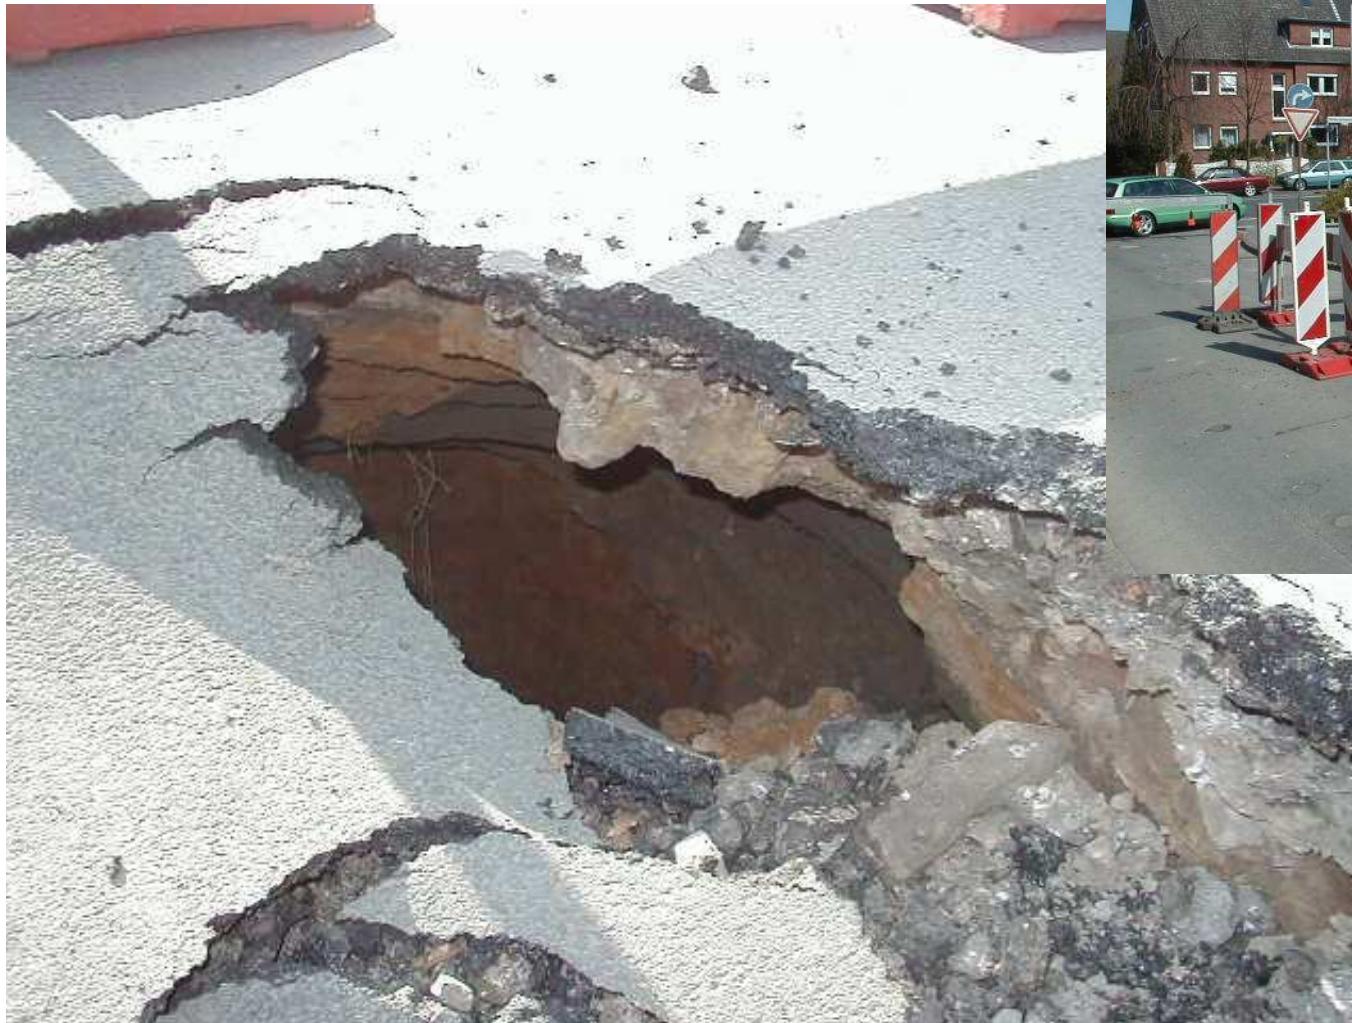
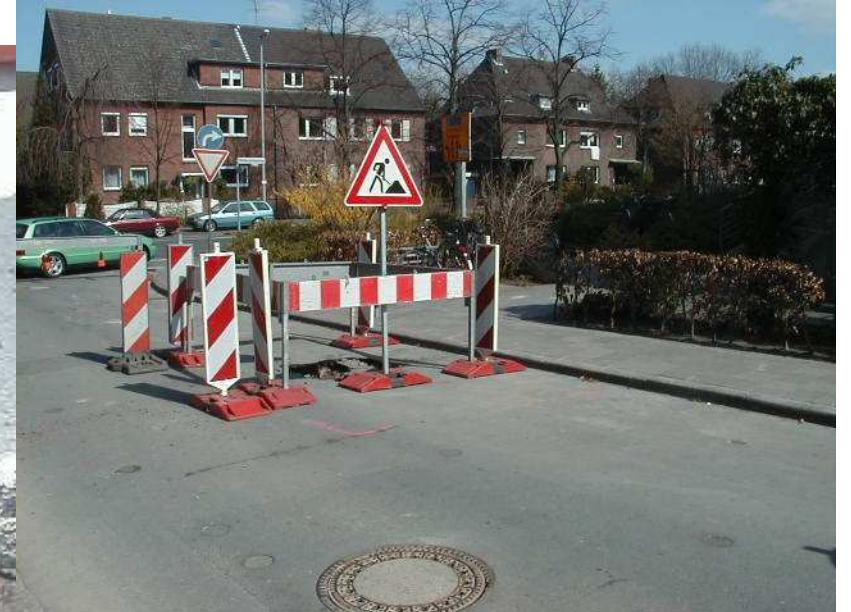
Sewer inspection

unseen damages

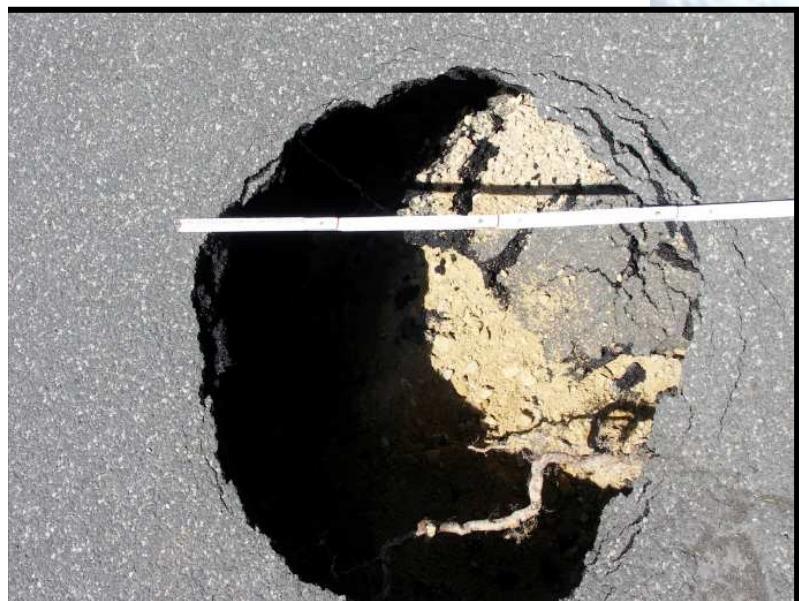
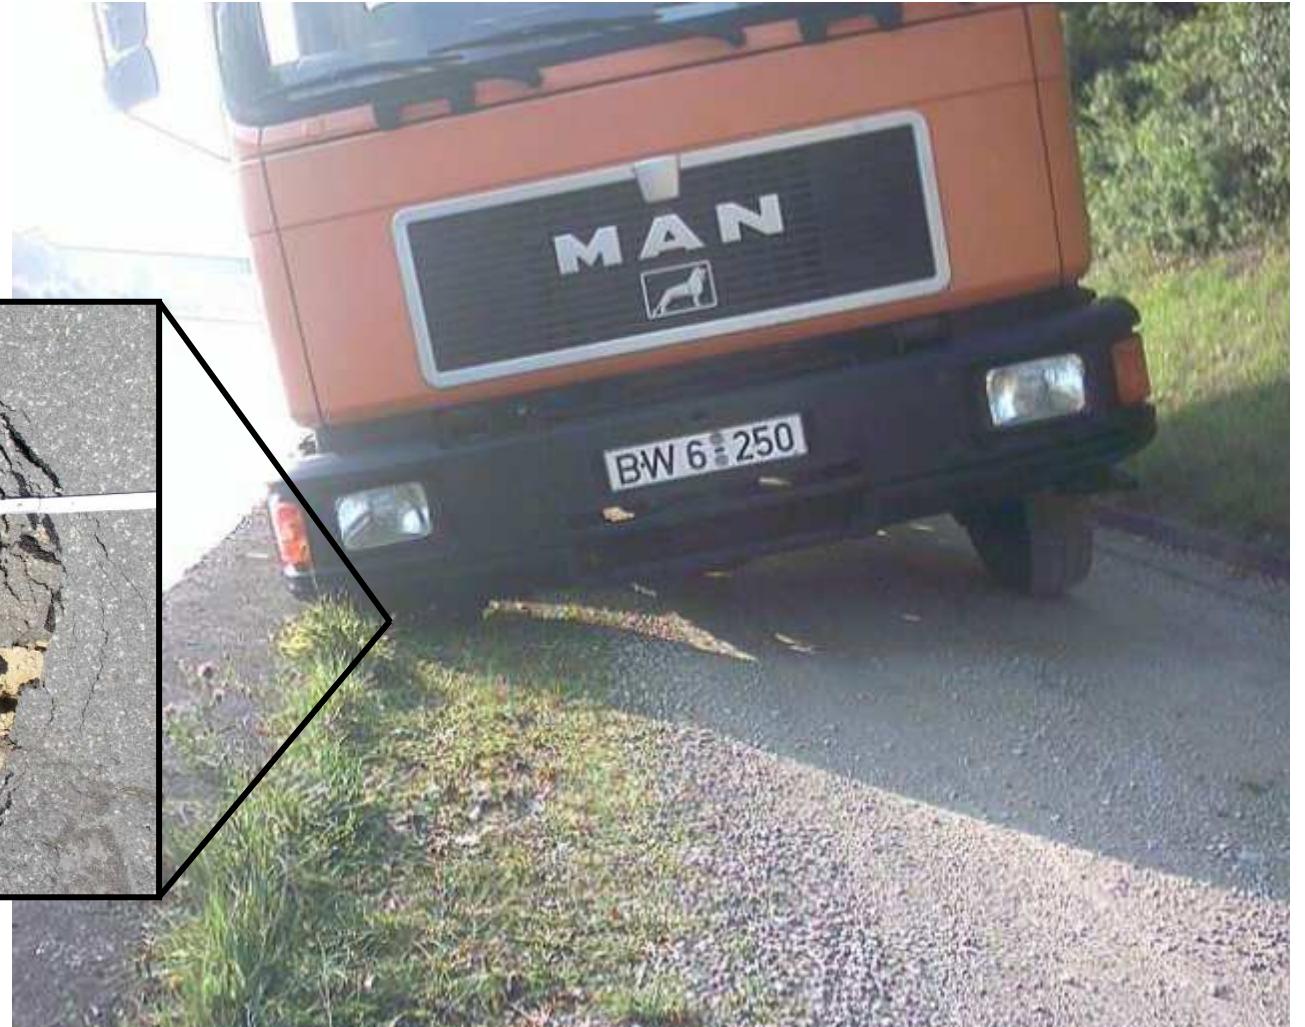
Sewer inspection

unseen damages

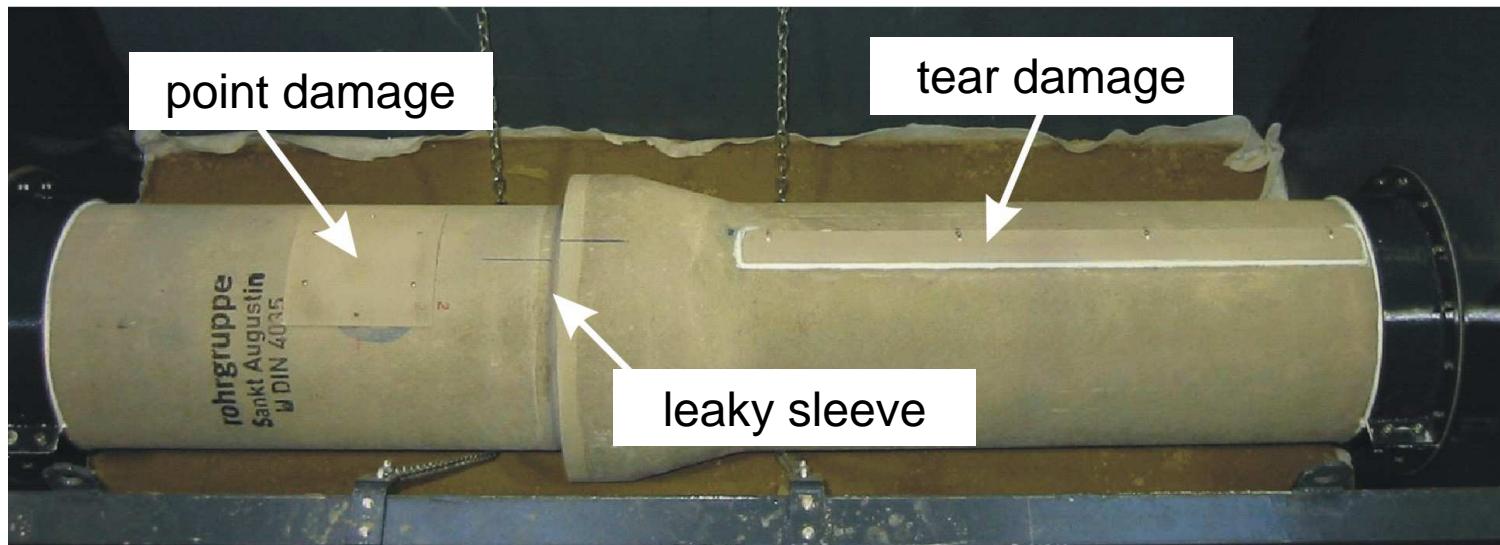
Pilot scale investigations

influence of damages to the sewer bedding

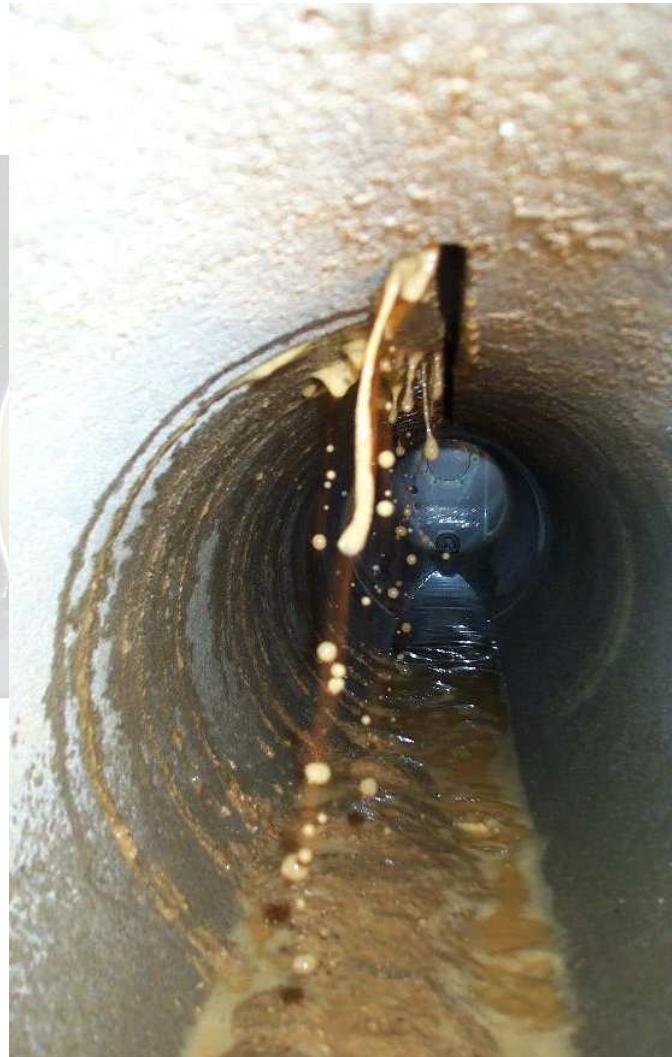
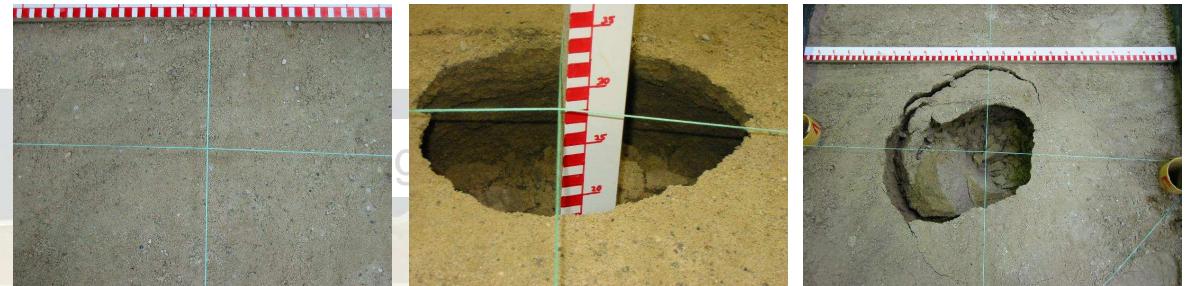
point damage 30 mm (soil SU)

195 min.

205 min.

250 min.

Damage	Classification regarding an endangerment of the stability of the soil body	Extent of the damage	
		Soil I (SU) (weak cohesive)	Soil II (SE) (loose)
Point damage	safe	$\leq 10 \text{ mm}$	$\leq 10 \text{ mm}$
	at risk	11 - 20 mm	11 – 14 mm
	critical	$> 20 \text{ mm}$	$\geq 15 \text{ mm}$
Tear damage	safe	$\leq 5 \text{ mm}$	$< 3 \text{ mm}$
	at risk	6 – 8 mm	3 – 5 mm
	critical	$> 8 \text{ mm}$	$\geq 6 \text{ mm}$
Leaky sleeve	critical	●	●
safe	below 1 litre of solid infiltration		
at risk	$> 1 - 10 \text{ litres of solid infiltration with a steady state}$		
critical	$> 10 \text{ litres of solid infiltration, no steady state}$

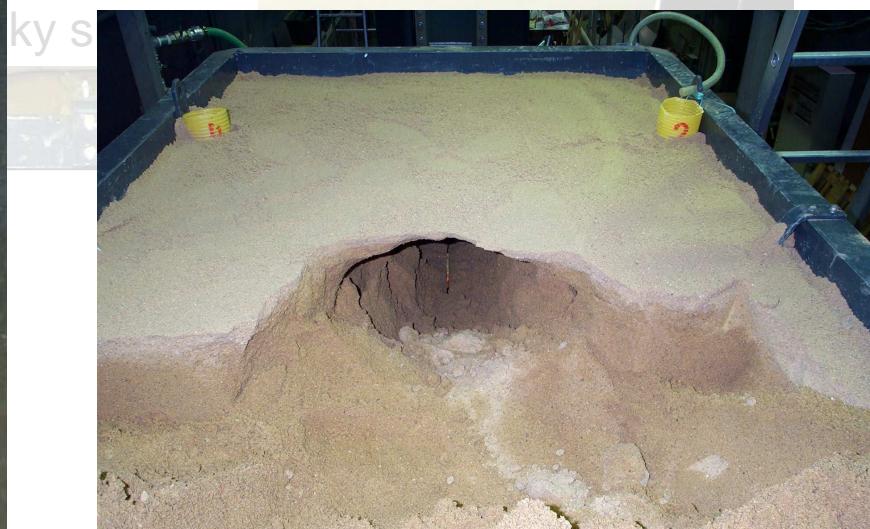
Tear damage 8 mm (soil SE)

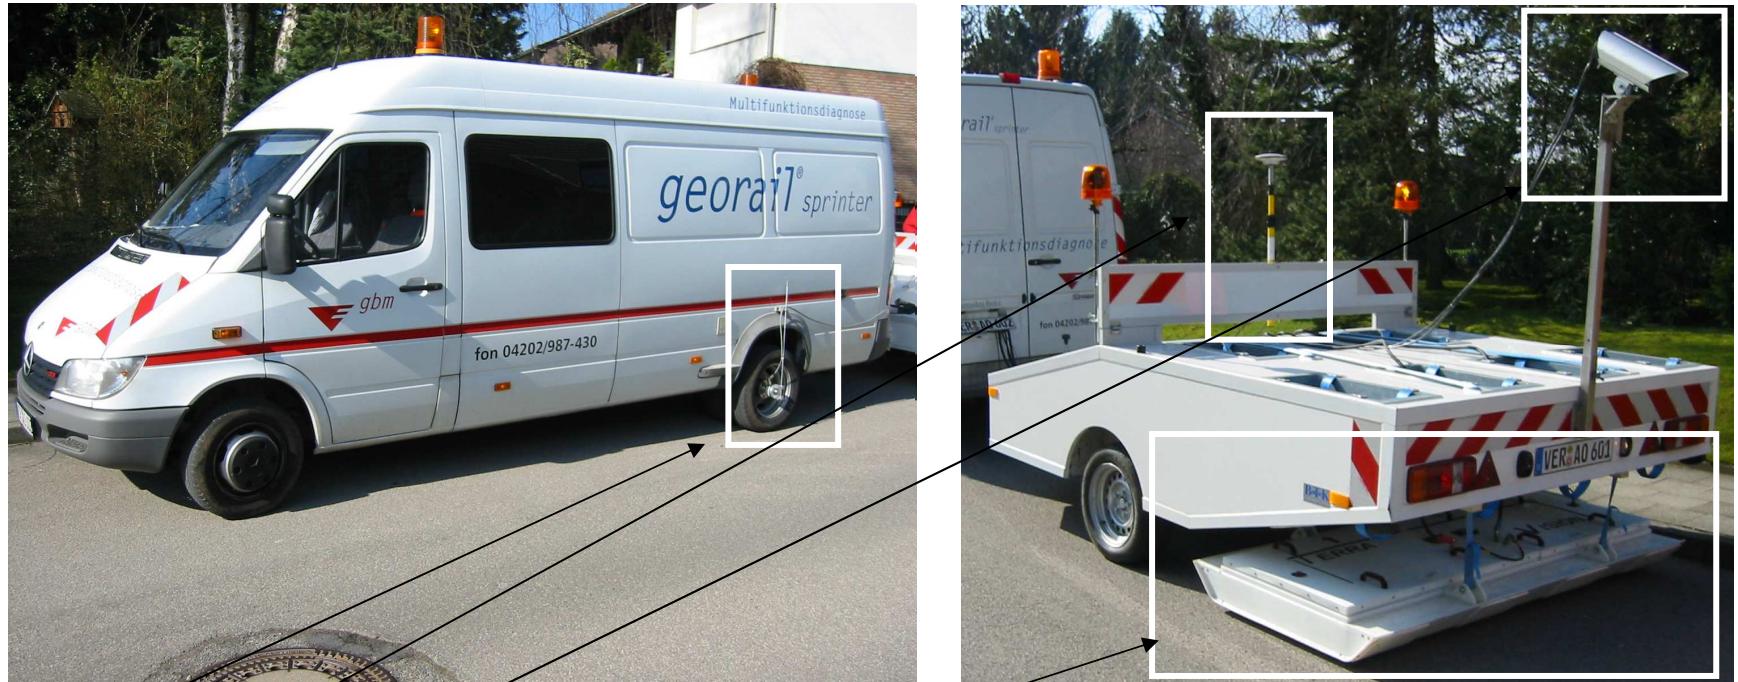
Measuring vehicle and trailer

1. Control unit, position indicator
2. GPS receiver
3. Camera
4. "TerraVision" Antenna Array (14 channels)

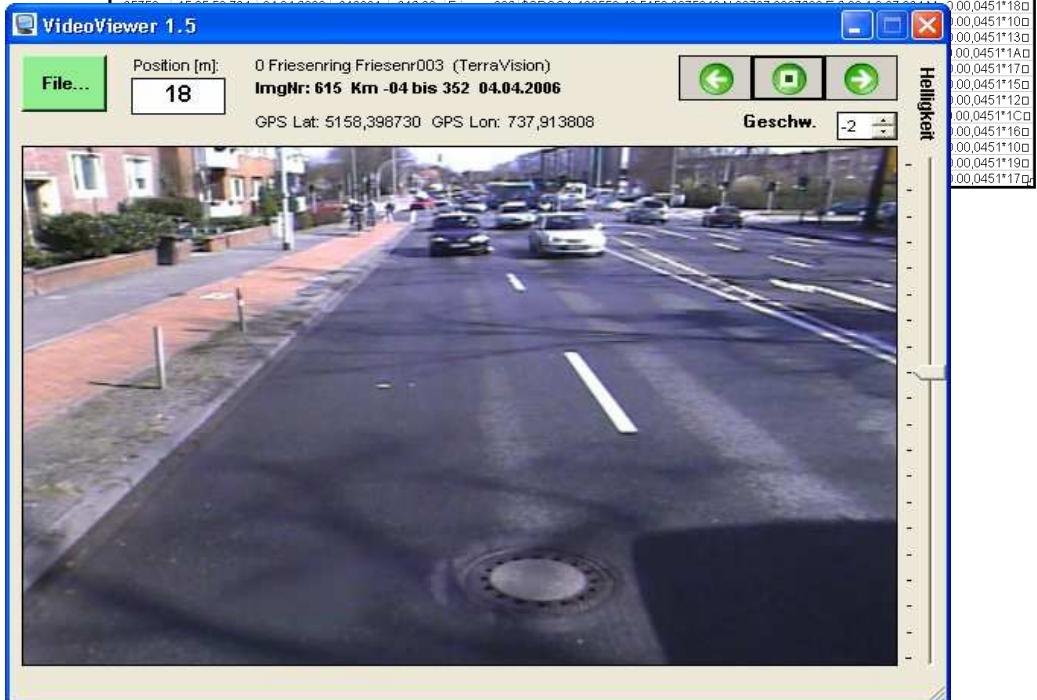
- GPS data
- Video

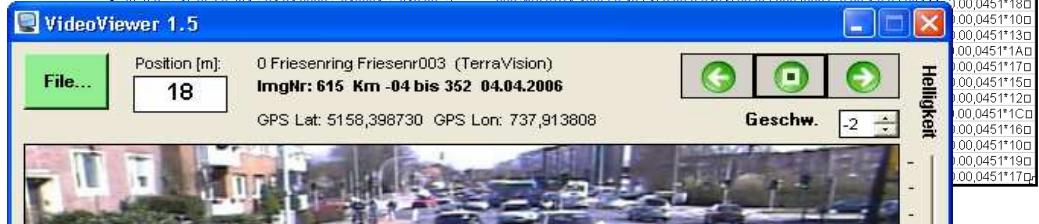
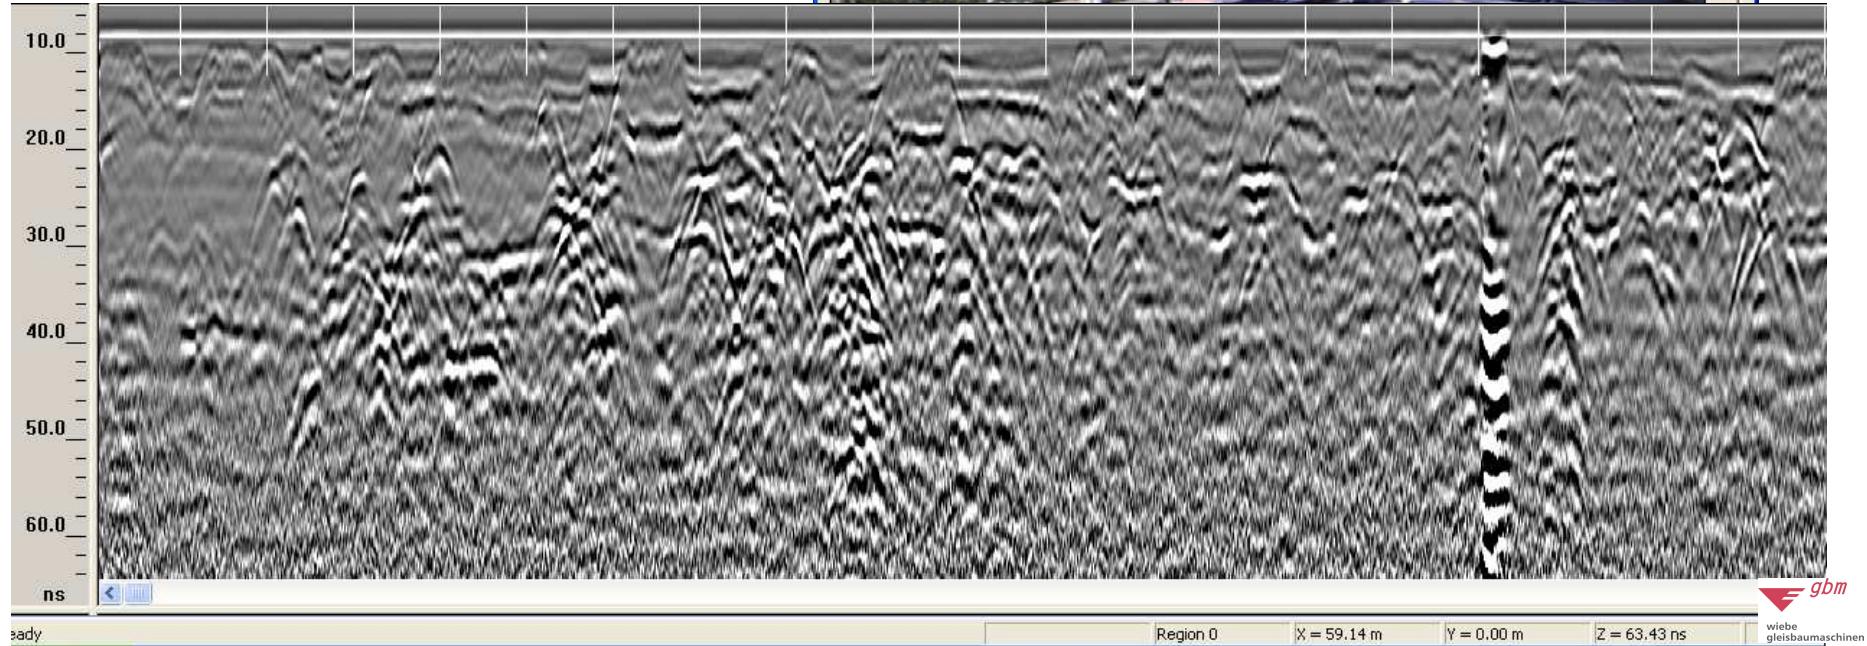
- GPS data
- Video
- Radargram

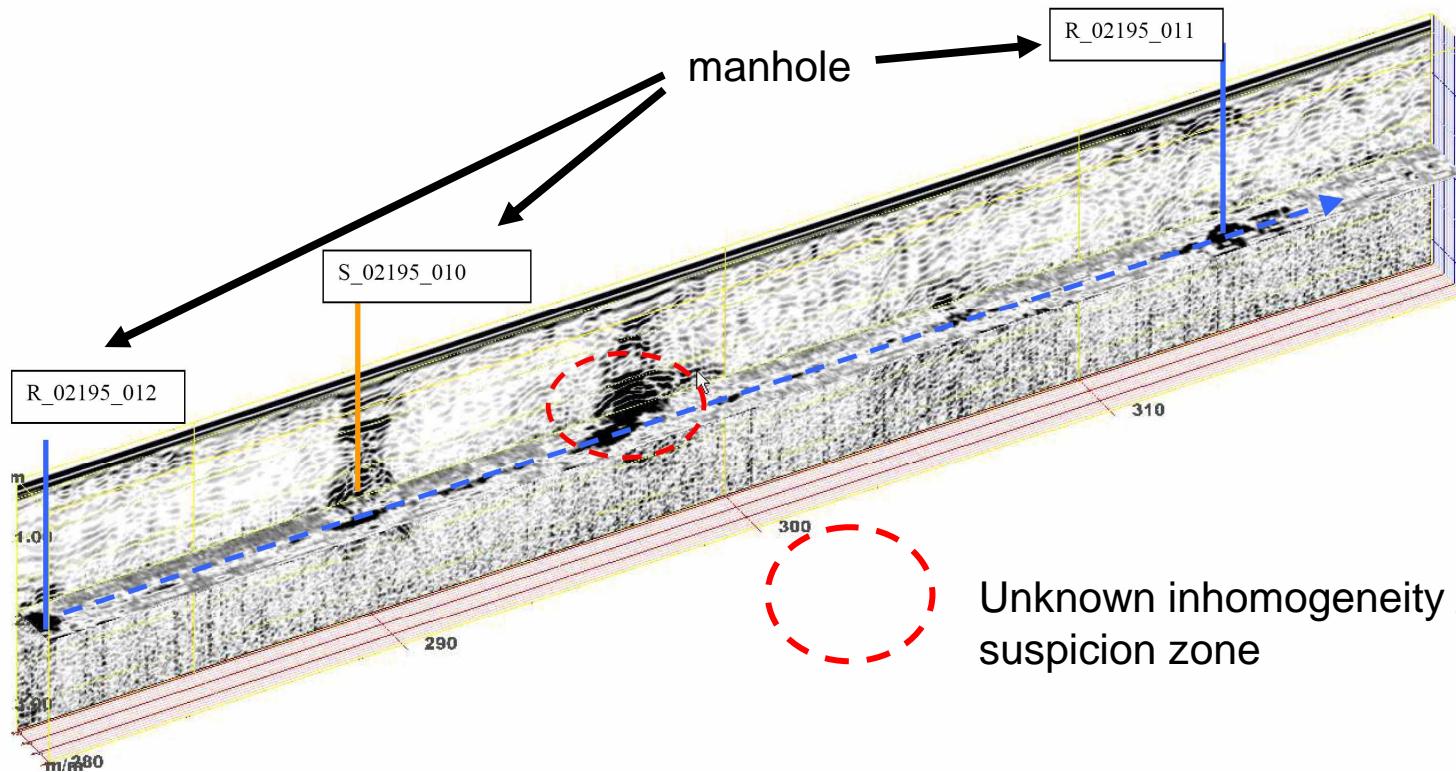
Radargram

- 3-D representation in form of the radargram

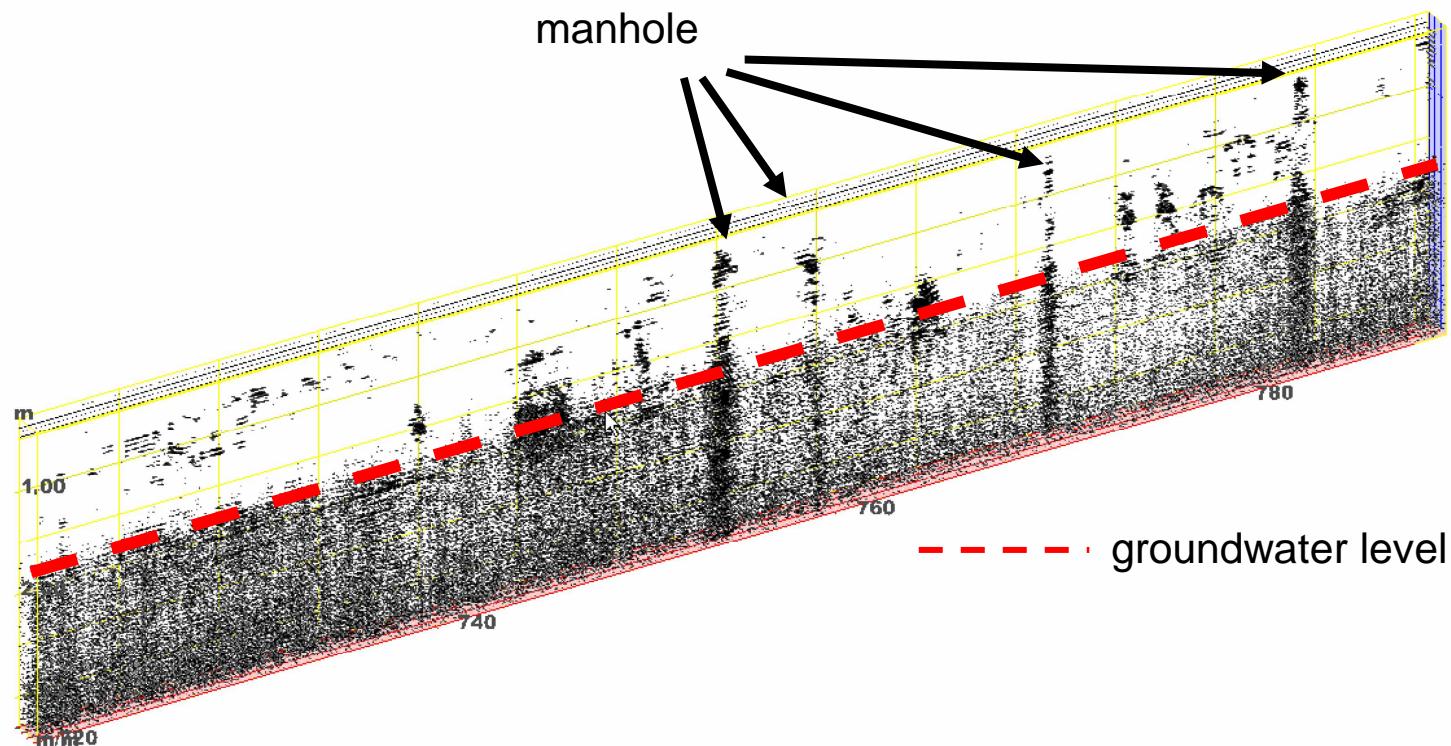
Radargram

- 3-D representation in form of the radargram

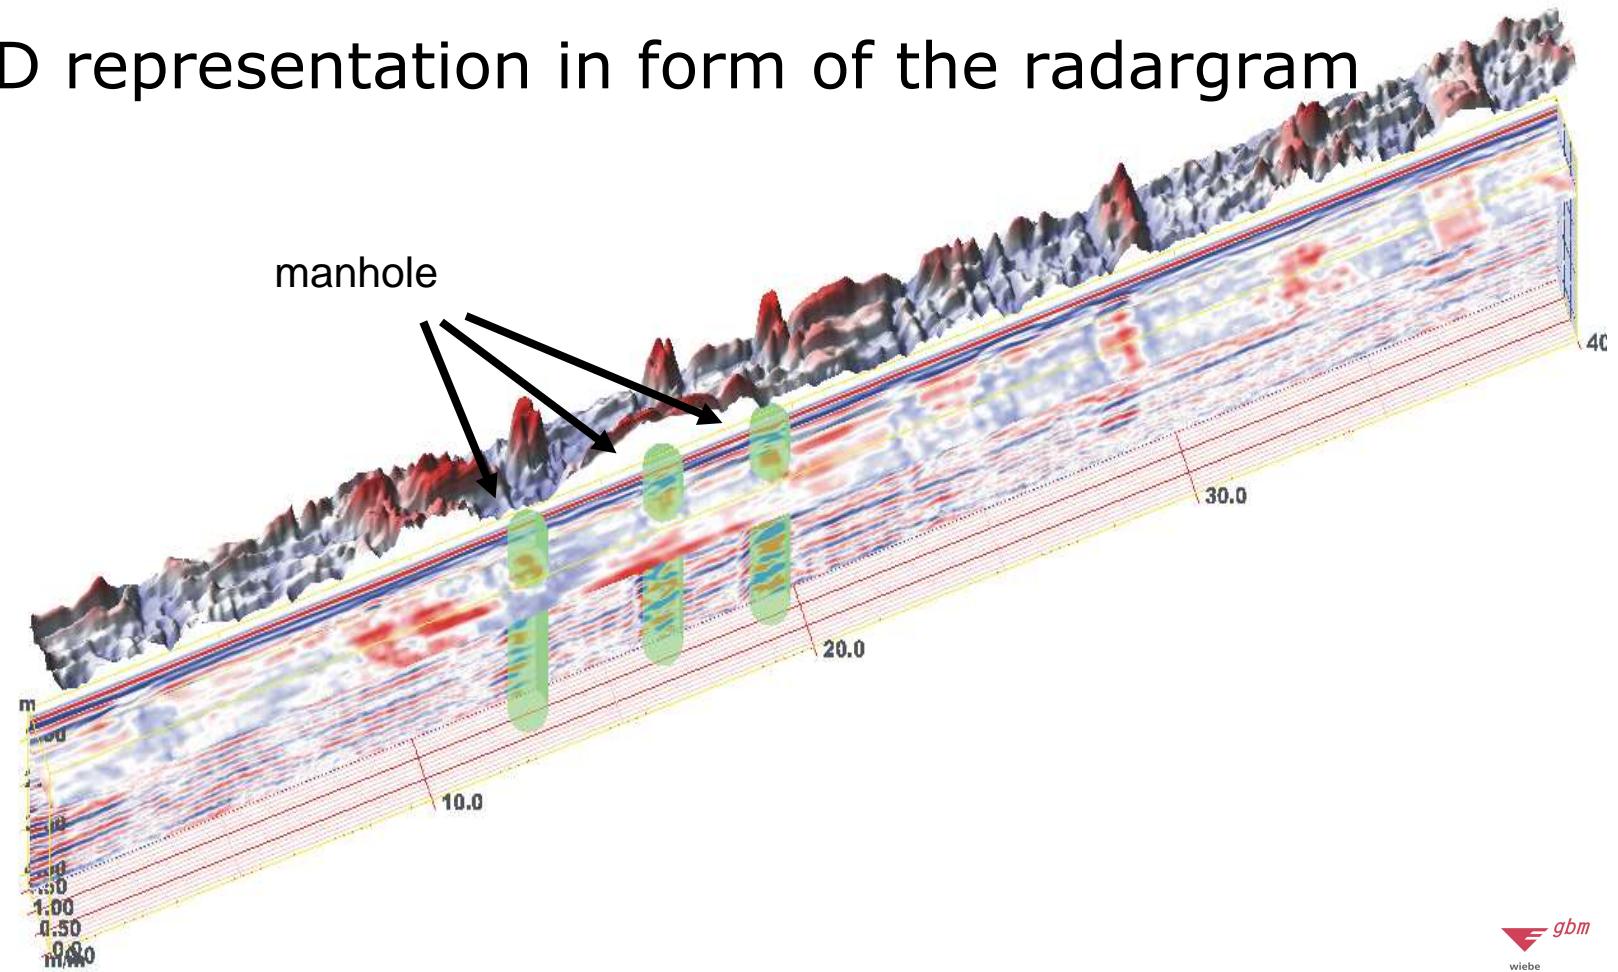
Radargram

- 3-D representation in form of the radargram

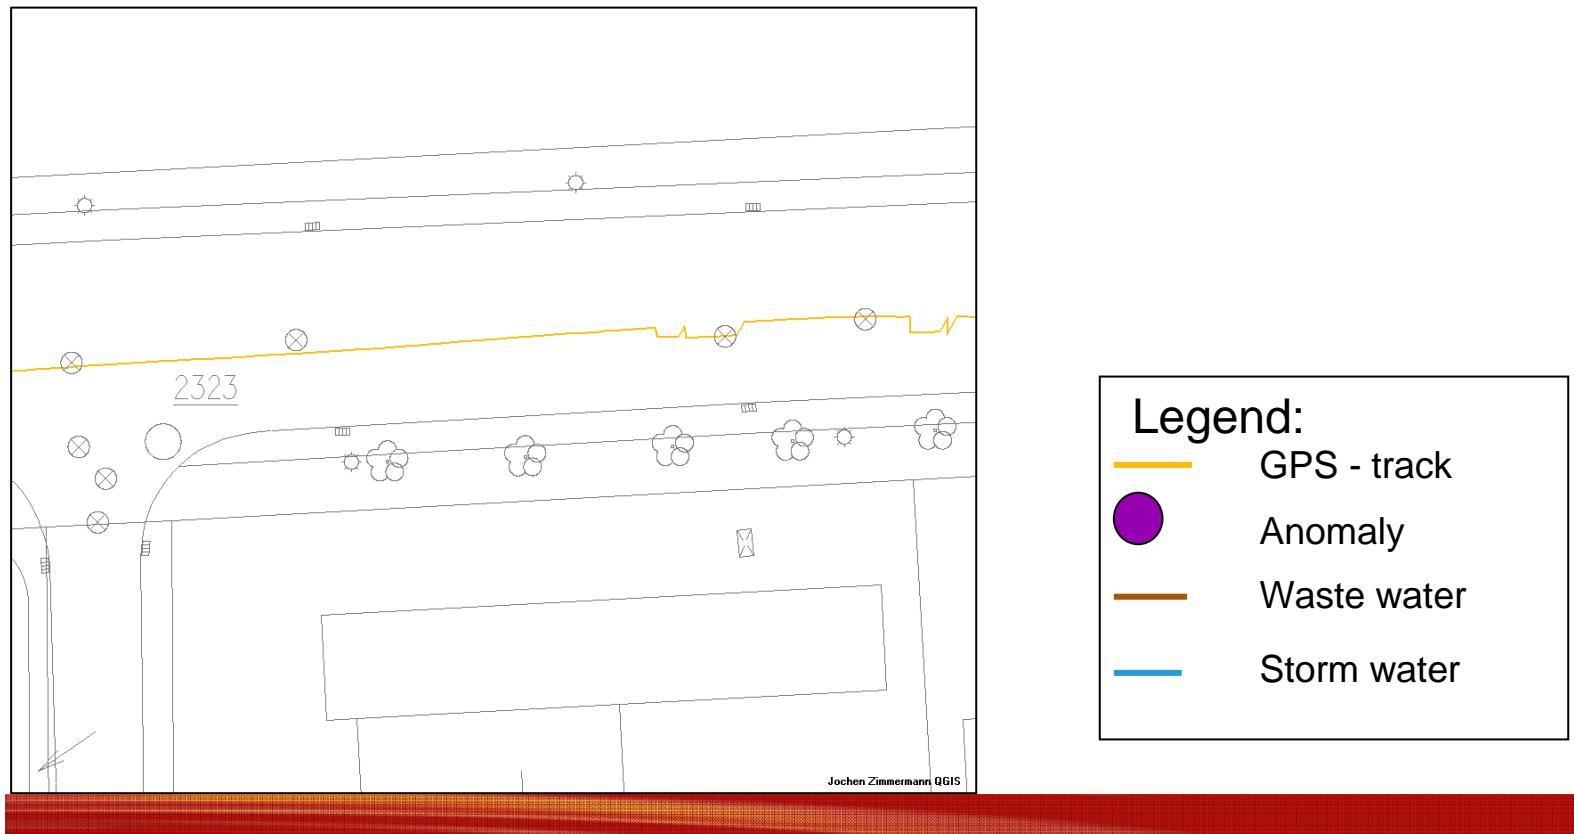
- 2-D representation, anomalies with additional card information

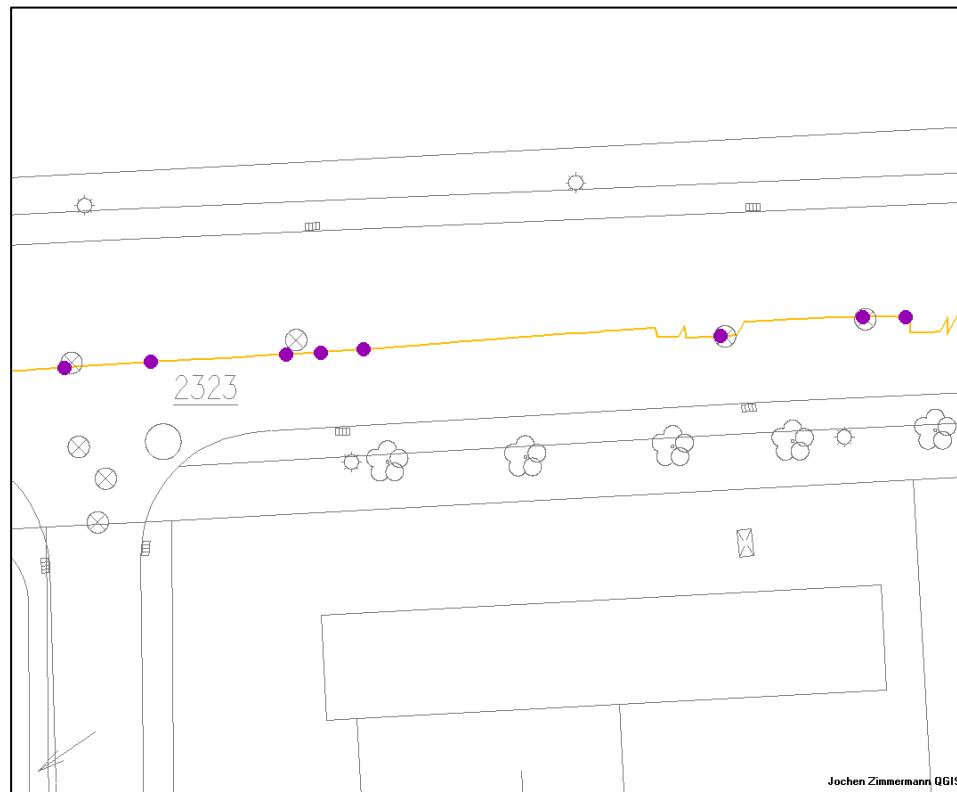
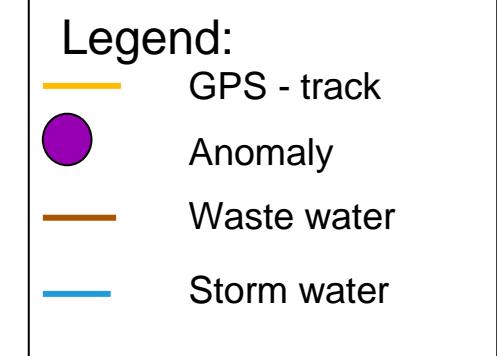
- 2-D representation, anomalies with additional card information

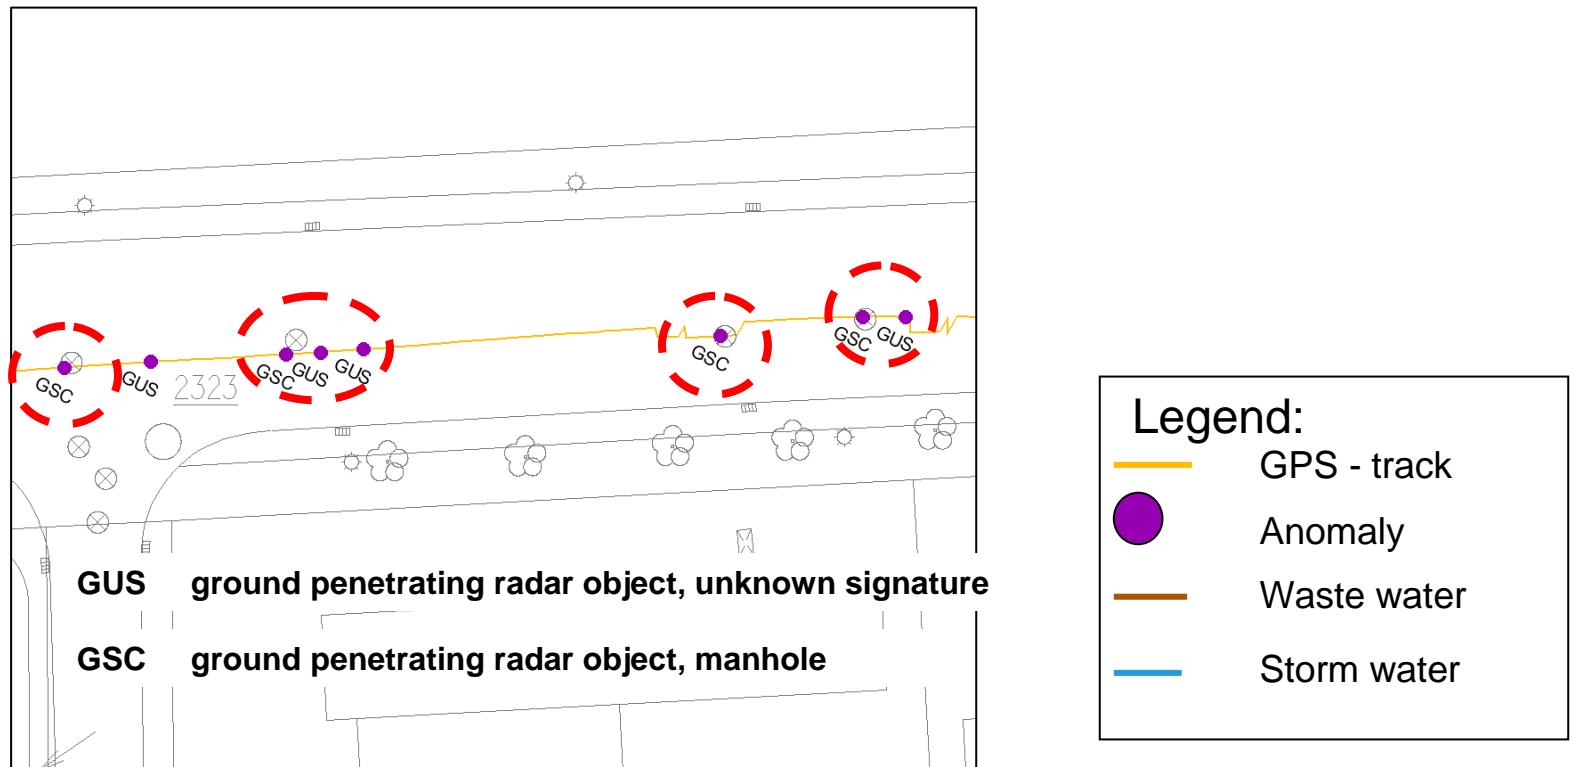
- 2-D representation, anomalies with additional card information

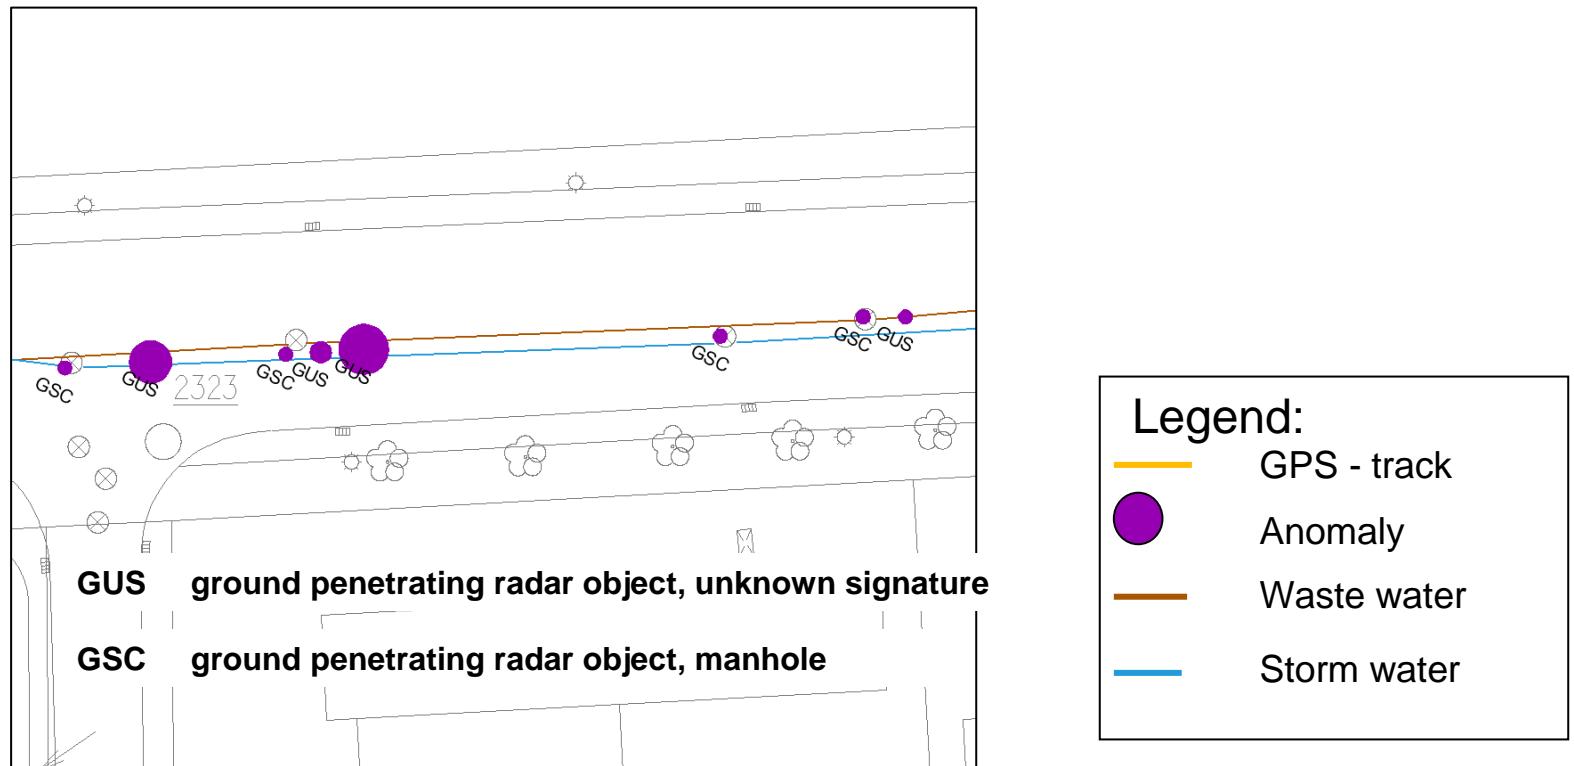
- 2-D representation, anomalies with additional card information
