# 2nd IWA Leading-Edge Conference & Exhibition on Strategic Asset Management

### Planning maintenance strategies for Italian urban drainage systems applying CARE-S

## Ugarelli Rita, Pacchioli M. & Di Federico V.

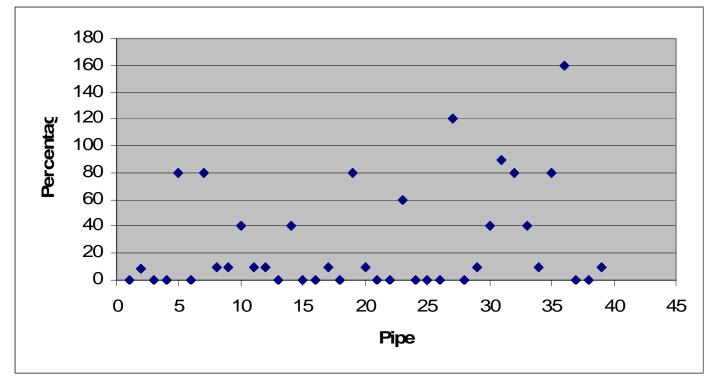
Condition grade	"Percentage"
5	220
4	170
3	80
2	10
1	0

### 26/39 pipes in c.g. 1-2

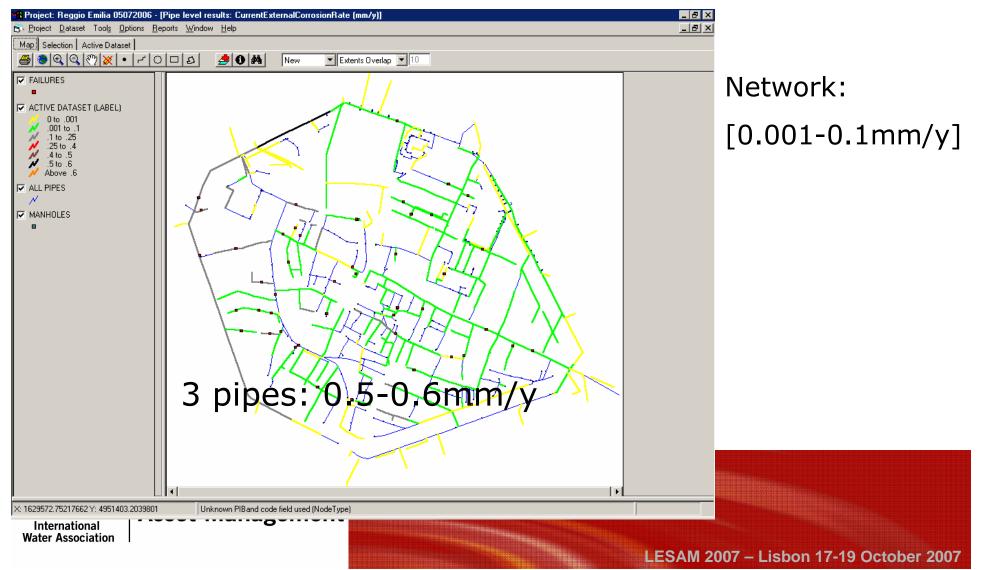
#### Current External Corrosion Rate (644 / 950 pipes analysed)

Parameter a (external corrosion in mm/year)						
	soil type					
moisture grade dry medium wet	non corrosive 0.01 0.05 0.01	medium corrosive 0.1 0.2 0.5	high corrosive 0.3 0.5 0.7			
Parameter b (pipe quality, water-cement ratio)						
resistance grade good medium poor water-cement ratio < 0,30 < 0,45 >=0,45						
ь		0.3 0.	7 1

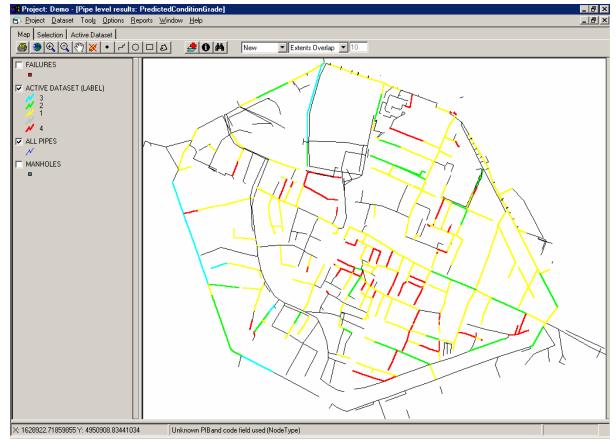
## Predicted Condition Grade (CG) at 2011

For the 483 pipes of the analysis, 330/483 pipes in CC1, best case, 30/483 in CC2, 6/483 in CC3 and 117/483 in CC4, the worst case.

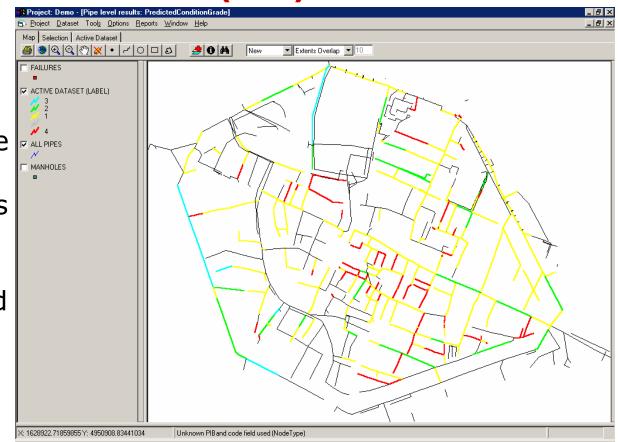
## Predicted Condition Grade (CG) at 2011

Looking at the worst case (CC4), the most representative material is Gres (64 pipes - 1759 metres) then PVC (52 pipes - 1026 metres) and Concrete (1 pipe - 52 metres).

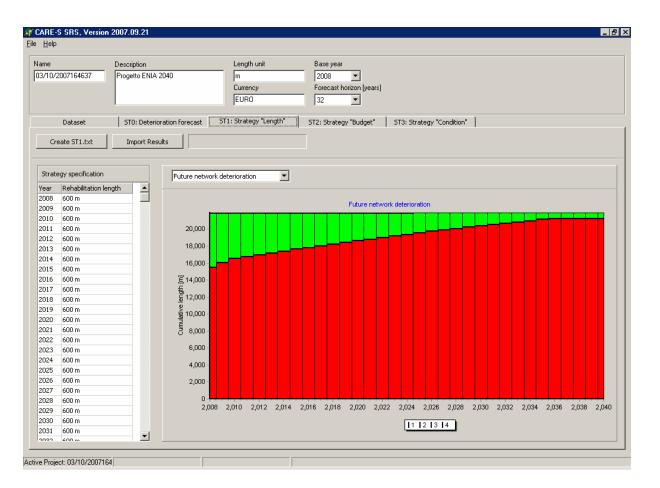
Future network deterioration

Testing hypothesis: Strategy: 600m/year Cost: 600€/m

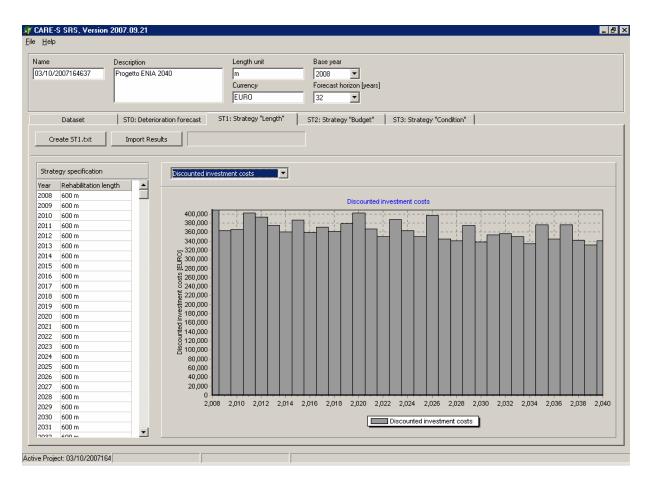
Discounted investment costs

Testing hypothesis: Strategy: 600m/year Cost: 600€/m

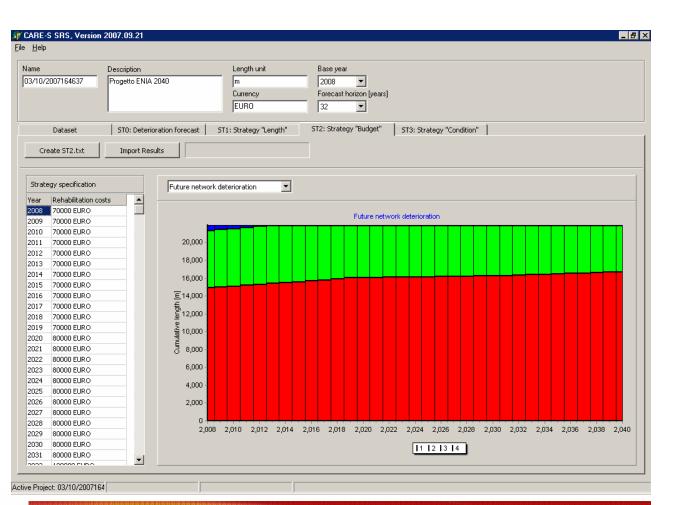
Future network deterioration

Strategy: 70000€/y until 2019 80000€/y until 2031 100000€/y until 2040

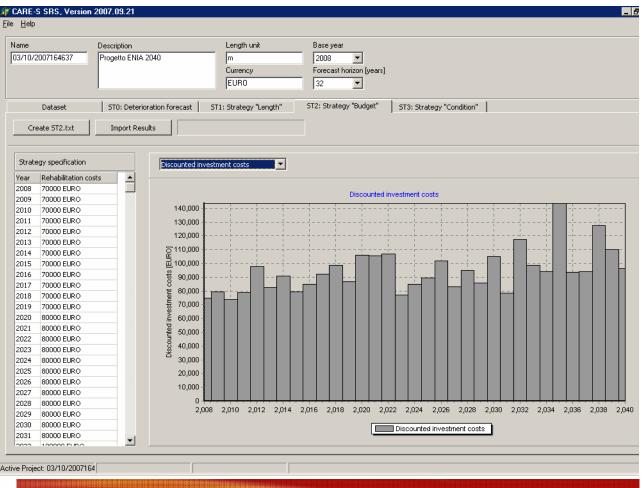
## Discounted investment costs

#### Strategy: 70000€/y until 2019 80000€/y until 2031 100000€/y until 2040
